PACKARD MOTOR CAR COMPANY  
DETROIT·MICHIGAN

May 14, 1923

TO PACKARD DISTRIBUTERS

BRAKE SQUEAKS

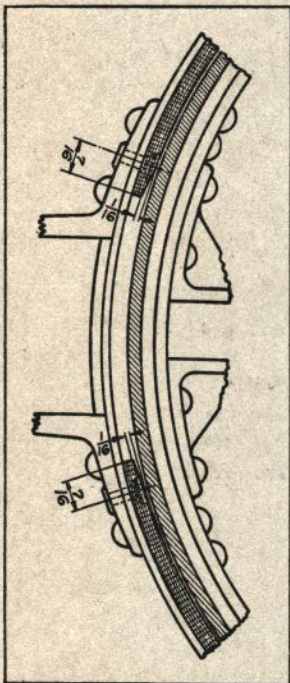
The procedure now in effect in the Factory has been found successful in correcting foot brake squeak on Single-Six cars, and may be followed in the field to take care of cars now in service.

The success or failure of this procedure rests entirely in the manner of treating the lining at this point, and if the illustration is carefully followed, no trouble will be experienced. The change took effect in the Factory in the neighborhood of motor number 29200.

The foot brake bands should be removed and the lining at the rear reworked, as shown in the illustration. The rear ends of the lining should project not more than 7-16" beyond the center line of the rivets and the lining should be pounded down at the end in the manner illustrated, so that when the brake is applied and the lining makes contact with the drum, there will be no sharp edge bearing against the drum.
