PACKARD MOTOR CAR COMPANY
DETROIT · MICHIGAN

November 5, 1923

Subject, Motor Crankshaft Rear Bearing Oil Leak.

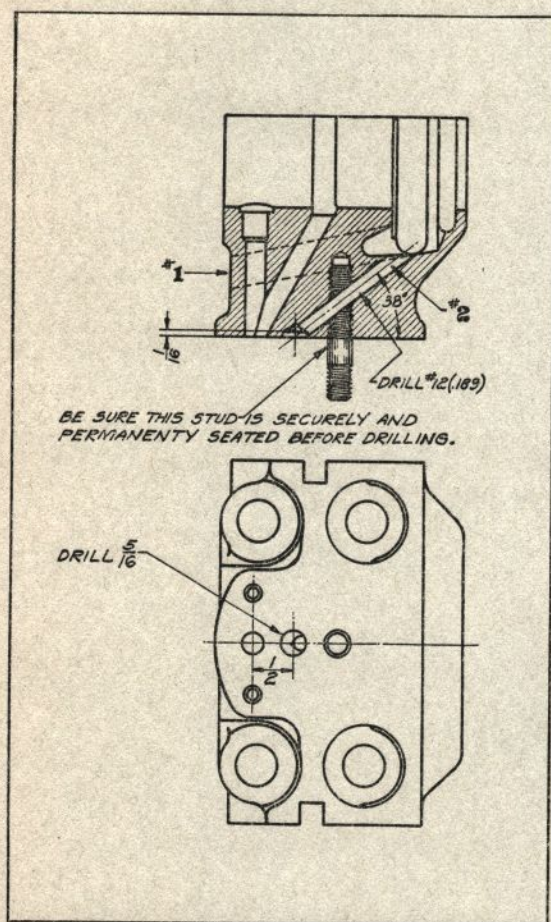
Instances have recently been brought to our attention where the installation of the drain tube in the crankshaft rear main bearing cap, as outlined in Technical Letter No. 1747, has not entirely eliminated an oil leak at this point.

The illustration shows how it is possible to provide more drainage by drilling two additional drain holes. No. 1 shows the original drain hole in the cap, and a similar hole the same size ($\frac{3}{8}$ ") should be drilled in the same relative position on the other side of the web.

The other additional drain is shown by No. 2 and is a No. 12 hole drilled at an angle of 38°. The location and angle of this hole are very important—

First—Because if the upper end of the hole does not meet the bottom of the oil groove it will be of little value.

Second—Because the lower end of the hole must be in line with the center line of the cap and $\frac{1}{2}$ " from the center of the oil hole or the oil will not drain into the crankcase. (Study the illustration, which clearly shows the location of the hole).

All three drain holes should meet the oil groove at the lowest point. If any of the drain holes do not connect with the oil groove in this way the cap should be chipped out, so that it would be impossible for oil to stand in the groove.

It is not necessary to install the drain tube as mentioned in Technical Letter No. 1747 if the cap is provided with the three drain holes described above.

In every case where this work is performed, the camshaft rear bearing cover plate should be inspected to make certain that part of the loss of oil is not due to a leak at that point.

The stamping formerly used for the cover plate has been superseded by Piece No. 121680, which is a heavy cast iron plate and requires longer cap screws, Piece No. 7856.
