PACKARD MOTOR CAR COMPANY

September 28, 1925.

To Packard Distributors.

Subject, Chassis Lubricating Tank.

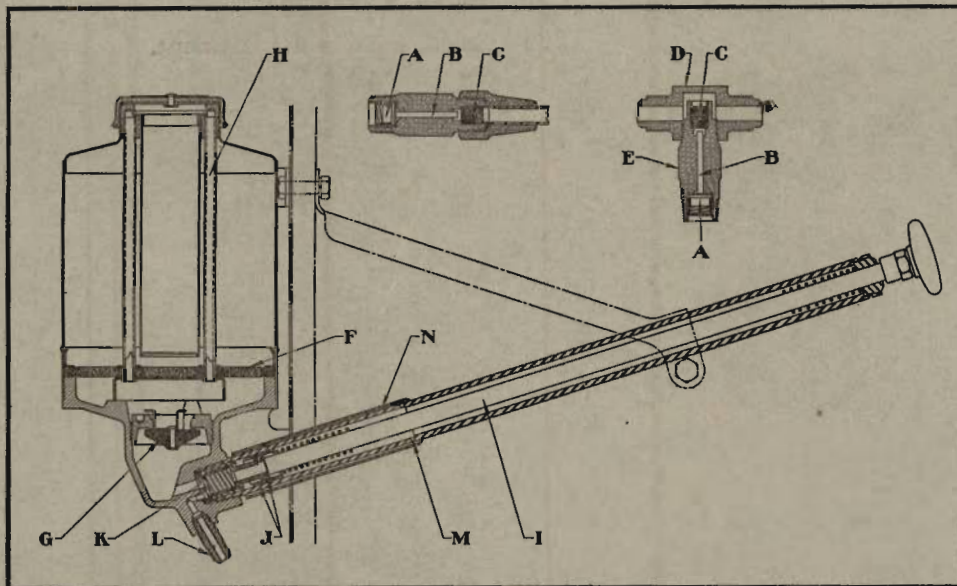
Several chassis lubricating tanks have been returned from the service field with a supposed defect of leakage. Upon inspection, these were found to be standard in this respect and in good working condition.

In the Bijur Chassis Lubricator the piston normally is spring pressed against a leather washer "K" which seals the oil in the tank from flowing into the gun, and which seals the hole from the gun to the outlet nipple "L." However, as leather even under the pressure of the piston, is slightly porous, about four drops per day ooze through this leather and tend to work up past the cup leathers "J" of the piston. In addition to this, whenever the gun is pulled and the piston is descending, a few drops of the oil under pressure beneath the piston gets by the cup leathers and so accumulates above them. Oil from either of these two causes would ultimately accumulate above the piston to a considerable extent and eventually come out at the top of the gun, were it not for four transverse holes drilled in the gun casing at "M" just above the upper limit of the travel of the piston. Such oil escapes through these holes and runs down outside the gun cylinder but inside the sleeve pressed over the lower end of the gun, to the forward side of the dash.

Thus, a few minutes after each gun stroke, a small quantity of oil will appear at the lower edge of this sleeve and run down along the casing on to the outlet nipple and the union nut screwed over it, and thence to the piping.

The presence of this oil on the nipple and nut should not be taken as indicating a leak. It is present more or less in every tank and should simply be wiped off or left to drip on the road. It should not be concluded from the oily appearance at the bottom of the sleeve that the tank leaks. This is an incident in its normal operation.

We therefore recommend that it be definitely determined that a leak exists before removing the tank, as the presence of oil on the dash below the tank or on the outlet connection does not always indicate a leak, for the following reasons:

When it is necessary to return one of these tanks to the Factory or the Bijur Corporation, it should be tightly packed in excelsior to prevent damage to the casing.
