# PACKARD MOTOR CAR COMPANY

May 18, 1927.

Subject, **STEERING KNUCKLE BALL BEARINGS**

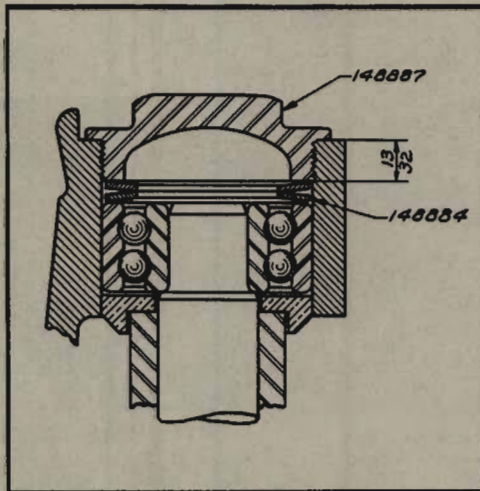
It has been the practice to assemble the front steering knuckle ball bearings rather snugly by means of shims under the upper plug, but we find that it is possible to impose an excessive thrust load on the bearings by this method, so that the ball races may become pitted or cracked.

This, of course, causes an unsatisfactory steering condition, and, to eliminate any possibility of this occurring, two concave spring washers have been designed to be used in place of the shims. These washers will prevent the bearings from being assembled with too much thrust load.

Two washers, piece number 148884, and a new plug, piece number 148887, are required for each knuckle and, after all shims have been removed, the washers should be assembled

with the convex faces toward each other, as shown in the illustration, and the plug pulled down firmly.

When present stock is exhausted the Service Division will supply only the new plug, which will, of course, necessitate the installation of the washers. The present plug can be reworked into the new design by cutting 3/16 off the threaded portion, which should then measure 13/32 from face of flange to the end.
