PACKARD MOTOR CAR COMPANY

January 30, 1930.

SUBJECT: OIL PUMP AIR BLEED

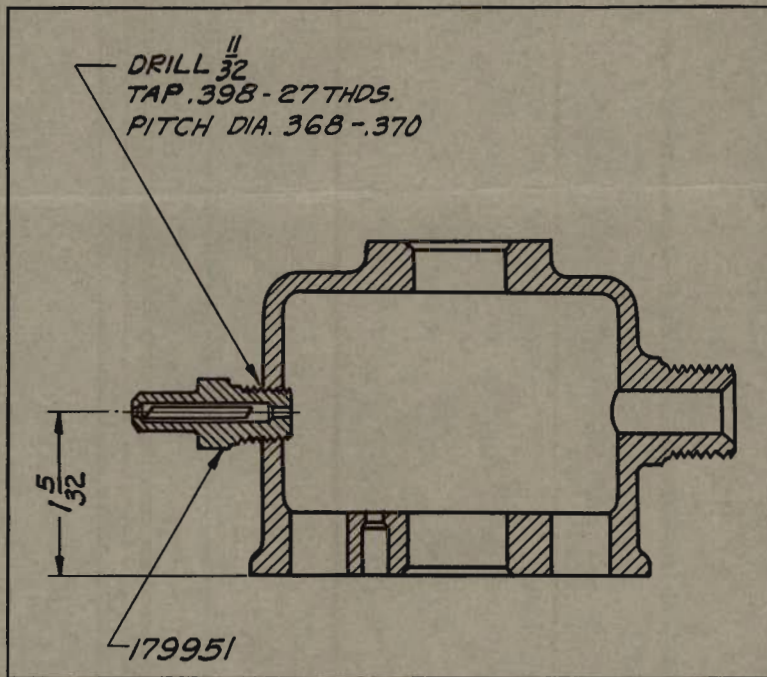
In certain cases it may be found that the flow of oil through the passages of the motor sets up a light knock. The condition does no harm, but may be criticised by the operator of the car, and a correction has now been found.

The oil knock is usually most noticeable with the motor running at a speed equivalent to 15 to 20 miles an hour, but sometimes the speed range through which it may be heard is very short indeed. The noise can usually be heard from the front seat, but it is most noticeable underneath the motor from the vicinity of the oil pump.

The oil hammer is always more evident when the oil pressure is high, and in some cases the condition can be corrected simply by reducing the pressure to the normal

amount. It can be definitely identified by disconnecting the piston lubricator valve from the choke mechanism, running the motor at the speed at which the noise is most evident and opening the lubricator valve. The drop in oil pressure will always eliminate the sound.

We have found that the oil noise may be reduced to a satisfactory point by installing an air bleed on the inlet side of the oil pump as shown in the illustration. This bleed admits a very slight amount of air to the oil pump and when this air passes into the oil lines it provides a sufficient cushioning effect to produce a satisfactory cure.

1—179951 Motor oil pump air bleed.
