# PACKARD MOTOR CAR COMPANY

April 4th, 1932

TO PACKARD DISTRIBUTERS AND DEALERS

## ACCELERATOR PEDAL CROSS SHAFT SPRING

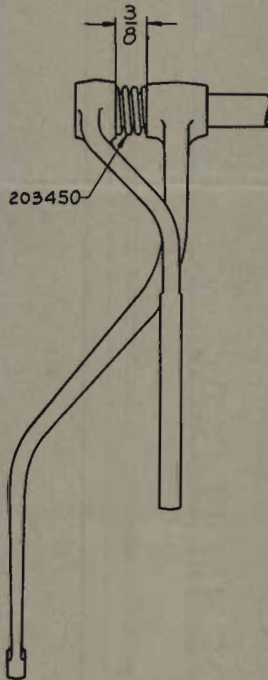
In cars equipped with the automatic clutch control, a rattle may be encountered in the throttle cross shaft which is mounted just forward of the dash.

This is now being corrected by the installation of a coil spring at the right side of the cross shaft between the lever and the bracket which is mounted on the intake manifold. The installation is shown in the illustration.

The condition can be corrected in cars already in service by the installation of this same spring. In order that it may have the proper tension there should be a clearance between the bracket and the lever of  $\frac{3}{8}$ " and the bracket should be bent if necessary to the proper point. If the clearance exceeds this amount, the spring may not be successful in stopping the rattle, and if it is less than  $\frac{3}{8}$ " it may bind the cross shaft. You will require for each car:

1—203450 Accelerator Pedal Shaft Lever Spring
