# PACKARD MOTOR CAR COMPANY

Subject: REAR AXLE HOUSING PACKARD SIX AND ONE TWENTY C

TL-1983

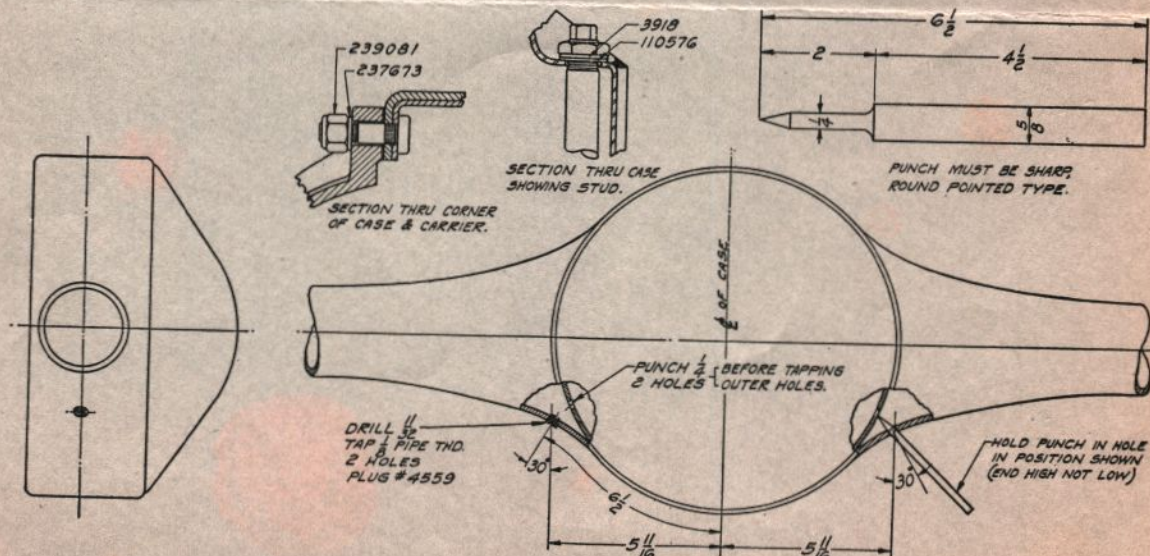
We have found that in the early housings of this design the oil had a tendency to work out of the center compartment surrounding the carrier by following the axle shafts through the felt wicks which seal the joint between the shafts and the compartment. A sufficient amount of oil may leave the compartment in this way to lower the level to a dangerous point.

Oil return holes are now being punched in the stamping which forms the compartment. The illustration shows the return holes and the method by which the first housings can be corrected. The housing itself should be drilled and tapped for pipe plugs, but the inner stamping should be punched as indicated because this will prevent any metal chips from entering the inner compartment. The easiest way to locate the holes in the "banjo" is by measuring  $6\frac{1}{2}$ " from the center line.

In addition to the above we have found some cases of oil leakage at the bolts which secure the differential carrier to the housing, and both the washers and the nuts should be changed. The new washer is a copper gasket identical with the gasket under the 10 m.m. spark plugs, and the nuts are a special self-locking design which will also prevent leakage. No lock washer is required. The old nut and lock washer should be discarded and replaced with—

8—No. 237673 Gaskets

8—No. 239081 Nuts

At the same time that the above work is done it will also be advisable to check the two through-bolts which project through the back cover, because leakage has also been detected at this point. We are now using a flat washer over the copper asbestos gasket, so that the tightening of the nut will not damage the gasket.

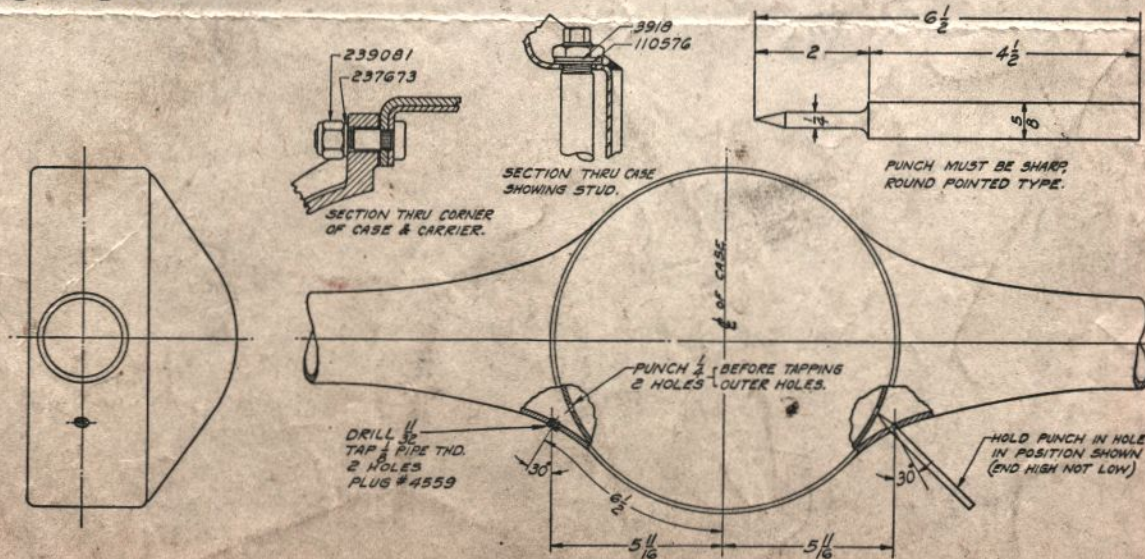
We have found that in the early housings of this design the oil had a tendency to work out of the center compartment surrounding the carrier by following the axle shafts through the felt wicks which seal the joint between the shafts and the compartment. A sufficient amount of oil may leave the compartment in this way to lower the level to a dangerous point.

Oil return holes are now being punched in the stamping which forms the compartment. The illustration shows the return holes and the method by which the first housings can be corrected. The housing itself should be drilled and tapped for pipe plugs, but the inner stamping should be punched as indicated because this will prevent any metal chips from entering the inner compartment. The easiest way to locate the holes in the "banjo" is by measuring  $6\frac{1}{2}$ " from the center line.

In addition to the above we have found some cases of oil leakage at the bolts which secure the differential carrier to the housing, and both the washers and the nuts should be changed. The new washer is a copper gasket identical with the gasket under the 10 m.m. spark plugs, and the nuts are a special self-locking design which will also prevent leakage. No lock washer is required. The old nut and lock washer should be discarded and replaced with—

8—No. 237673 Gaskets

8—No. 239081 Nuts

At the same time that the above work is done it will also be advisable to check the two through-bolts which project through the back cover, because leakage has also been detected at this point. We are now using a flat washer over the copper asbestos gasket, so that the tightening of the nut will not damage the gasket.
