# PACKARD MOTOR CAR COMPANY

To PACKARD DISTRIBUTERS AND DEALERS

July 8, 1937

Subject VAPOR LOCK

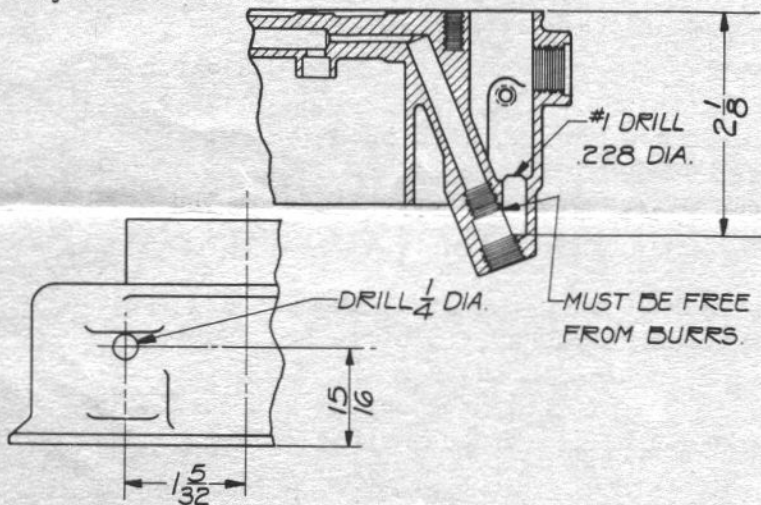
During the last few months we have found indications of vapor lock or percolation in the Packard Six which have not been evident in the other models, and in addition to the general measures outlined above, special steps may be taken if required.

2. Drill an additional vent hole in the air horn, as shown in the illustration. This is for the same reason.
3. Replace the main metering jet with the latest design. This new design prevents gas from pocketing. While doing this, make sure that the passage supplying the fuel to the main metering jet has no overlapping burrs at the lower end which will enable a gas pocket to form. If necessary the passage should be drilled out with a #1 drill, .228 in diameter, making sure not to drill so deeply as to injure the seat. Do not drill deeper than 2 1/8" from the upper face of the carburetor body.
