# PACKARD

# *Service Counselor*

VOL. 20 NO. 11

NOVEMBER, 1946

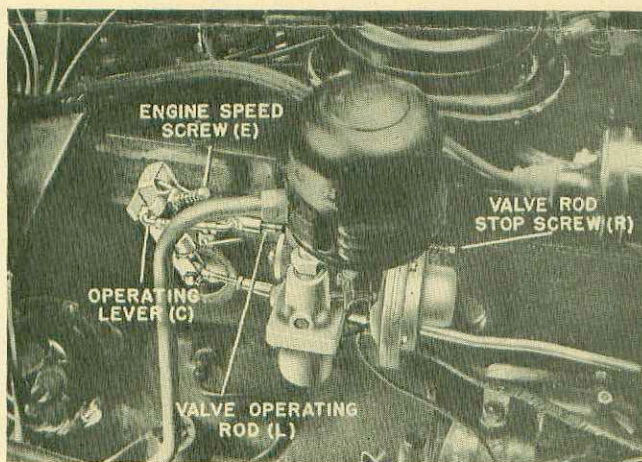
The 21st series Electromatic clutch control valve is of the type that regulates the degree of clutch engagement or disengagement in accordance with the degree of throttle opening. The construction and operation of the 21st series clutch control valve is such that normally, only two adjustments need to be made, namely:

1. The engine speed screw "E" controls the engine speed at which the clutch engagement starts.

2. The valve rod stop screw "R" controls the depth of engagement as the throttle is opened further.

Adjust engine speed adjusting screw "E", so that car will just move on a level floor when the operating lever "C" is brought up against adjusting screw "E". Then turn adjusting screw "E"  $\frac{1}{2}$  turn clockwise.

Back off valve rod stop screw "R" until screw extends  $1\frac{1}{4}$ " from valve cover. This will cause a very rapid clutch engagement, and may cause the engine to stumble or hesitate. Then turn stop screw "R" clockwise  $\frac{1}{4}$  turn at a time until satisfactory full throttle engagement is obtained without excessive clutch slippage. Care should be taken not to heat the clutch excessively by slipping the clutch during this adjustment. **CAUTION:** Do not oil or lubricate valve operating rod "L" under any circumstances.
