PACKARD

Service Counselor

VOL. 22, NO. 6

APRIL 15, 1948

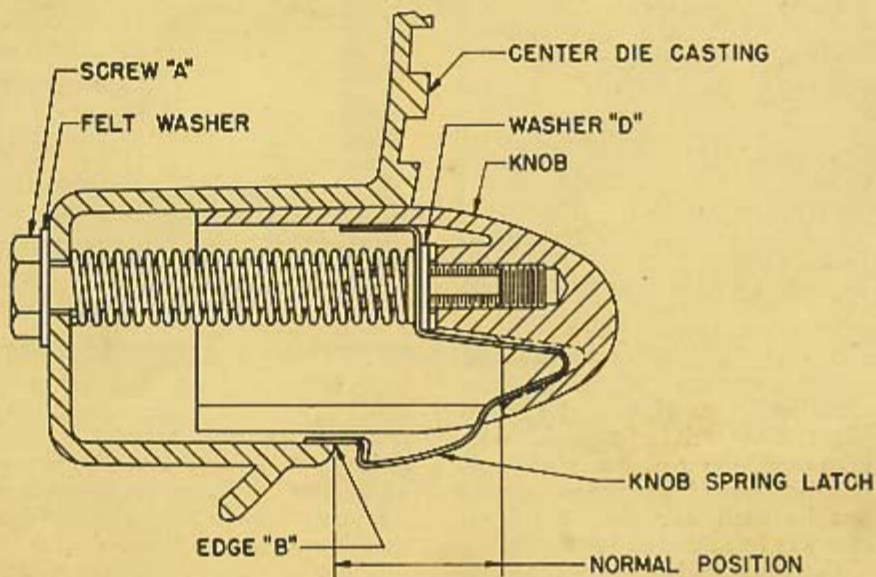
Headlight Switch Latch 22nd Series

As a result of product reports received from the field, a steel spring latch is being installed in the headlight switch knob to reduce the possibility of unintentionally extinguishing the headlights. These latches are now being installed in production and are also available for installation in Service.

To operate the headlights on cars equipped with this latch it is necessary to press both the latch and the switch knob at the same time. This can be accomplished by pressing the latch up into the knob with one finger while using the thumb to press the knob.

These new latches are carried under piece number 403912.

Instructions for installing the latch are as follows:

1. Remove the two slotted switch retaining nuts and lower the switch support to give access to the headlight switch knob retaining screw. (Screw "A" in illustration.)

2. Loosen screw "A" until the switch knob, spring, and the washer can be removed.

3. Remove burrs, if any, along edge "B" of die casting.

4. Slide the latch onto screw "A" and reinstall the washer "D" as shown in the illustration.

5. Reinstall the switch knob and tighten screw "A" to relocate the knob in its original position with the end of the latch resting above edge "B".

6. Test the action of the latch by pressing the latch up into the knob and pushing the knob to light the lights. Release the knob and make sure it returns to its original position with the latch in the locked position as shown.
