Suggestions for Sealing Water Leaks

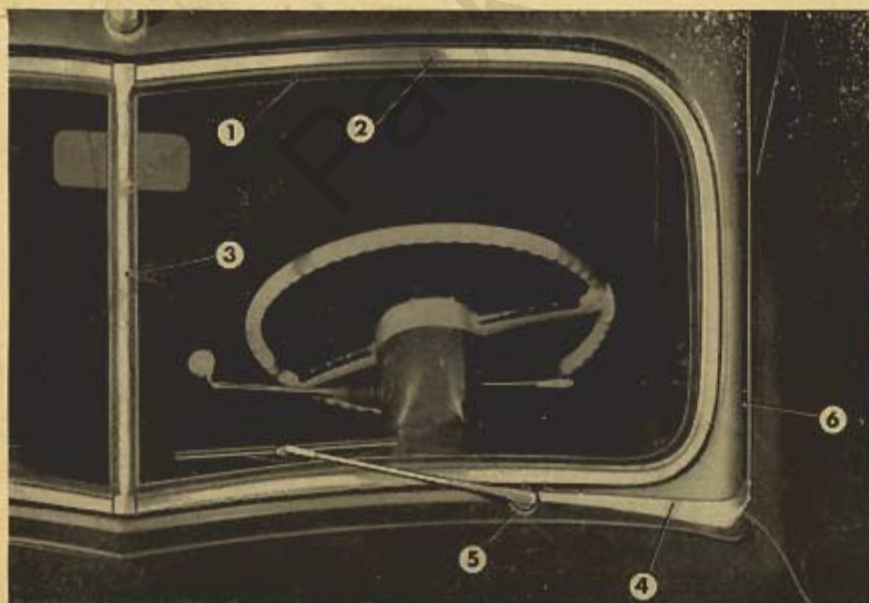
Fig. 1

Water leaking into the front compartment can generally be traced to one of the points indicated in figure 1.

When water leaking into the front compartment cannot be traced to the windshield, the point of entry is often very hard to locate. Water may enter through the cowl side belt moulding (4) stud attachment holes, between the windshield cleaner pivot shaft spacer gasket (5) and the body, or through the seams at the roof rain gutter moulding (6). In all of these cases the water may run onto the forward side of the instrument board and finally drip, or it may follow the cowl side panel and show up at the base of the cowl side trim panel. Water appearing at the base of the trim panel may also be entering between the fresh air duct adaptor gasket and the body.

When leaks are traced to the windshield, the method of sealing is simple. If the water appears between the glass and the weatherstrip inside the car, apply liquid body sealer between the glass and the weatherstrip around the entire windshield on the outside of the car. If the water appears between the finishing moulding and the weatherstrip or the moulding and the instrument board, apply liquid body sealer between the weatherstrip (1) and the outside finishing moulding (2), between the outside moulding (1) and the body around the entire windshield, and between the outside division finishing moulding (3) and the weatherstrip. In addition, in cases where a severe leak enters at the division finishing outside moulding, it may be advisable to remove the division moulding and fill the screw holes with "dum-dum" to make a watertight seal at that point.

Minor leaks at the cowl side belt moulding (4) may be sealed by forcing liquid body sealer between the moulding and the body. In case of a severe leak at this point remove the moulding, fill the stud attachment holes with "dum-dum" and reinstall the moulding.

Leaks at the windshield cleaner pivot shaft (5) may be corrected by removing the wiper arm and then removing the spacer retaining nut. Lift off the spacer and the gasket, apply rubber cement to both sides of the gasket and reassemble.

If water enters the body at the spotwelded joints of the roof panel and the rain gutter moulding (6), seal along the entire seam. Using

a caulking gun, force sealer well into the spotwelded crevices. After

excess sealer has been cleaned off, the area sealed may be touched up with color to match the body.

Water entering at the fresh air duct adaptor gasket may be eliminated by applying liquid body sealer between the gasket and the adaptor and between the gasket and the cowl panel around the entire gasket.

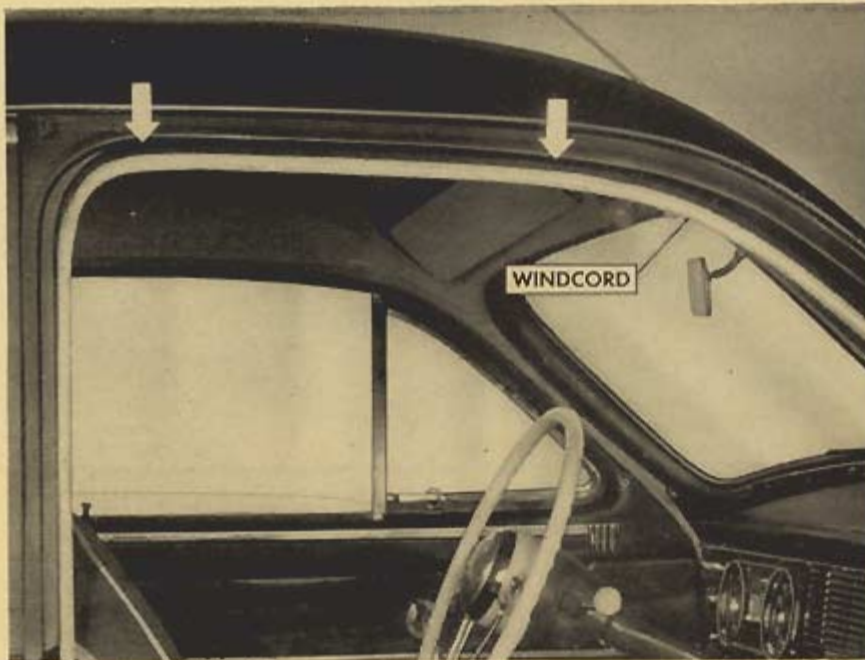
Fig. 2

Wet windcord around the doors is an indication of poorly fitting weatherstrips, especially at the top

or front edge of the doors. (See figure 2). To check this condition, place narrow strips of paper between the door weatherstrip and the body opening and use them as a feeler gauge to determine whether or not the weatherstrip is contacting the body. A drag should be felt when the paper strips are pulled. Sections of the weatherstrip which do not make proper contact with the body should be shimmed by cementing strips of rubber between the door and the weatherstrip.

The stub arrows in figure 2 indicate the welded joints and seams at the top of the door opening where the roof rail and pillars are joined. If the metal is rough or has a depression, leakage past the weatherstrip may result. To correct a leak at these points, smooth or fill with glazing compound and touch up when dry.

Leaks at the curved section of the front doors, opposite the instrument board, are usually due to insufficient compression of the weatherstrip on the body. Remove the retaining screws and install a thin piece of rubber behind the weatherstrip and reinstall the screws.

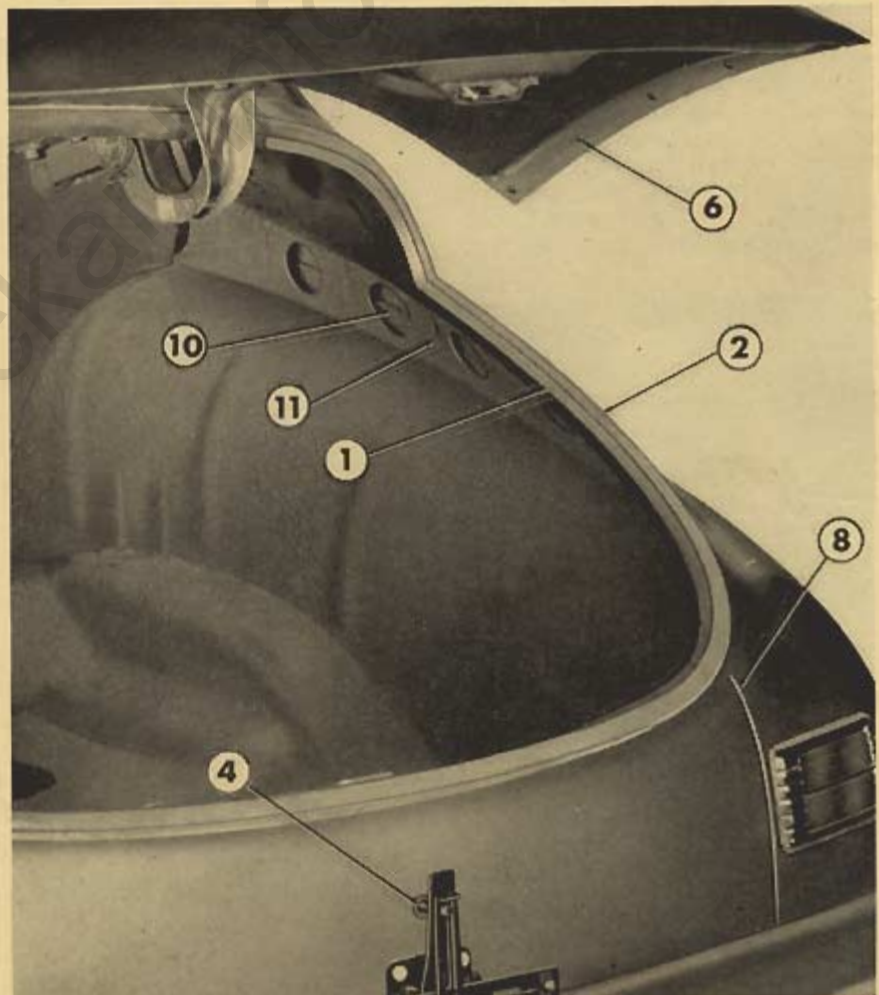
Fig. 3

Water leaking into the trunk compartment can generally be traced to one of the points indicated in figures 3 and 4.

BELT Moulding CLIPS — Water may enter through the belt moulding attaching holes (3). When leakage appears at these holes, remove the moulding and fill the holes with "dum-dum." Apply "dum-dum" to each clip, reinstall the moulding and apply "dum-dum" around the holes from inside the trunk compartment.

Attachment holes for the license plate bracket (4), the rear end grille (5), and the trunk lid moulding (6) should be inspected for leakage. If there is indication of leakage at any of these places, remove the parts, apply sealer at the point of leakage and reinstall the parts.

BODY SEAMS—When leakage is apparent but no point of entry can be found in the vicinity, the body seam above the rain gutter (7) should be sealed. It is possible for water to enter this seam near the front of the car and run back into the trunk compartment.

Leaks are sometimes found at the seams (8) between the rear end center panel and the fenders. A leak at these points may be sealed by filling the seams with sealer. After sealing, the surface at the seam may be touched up with paint to match the body color.

The seam (9) between the roof panel and the rear quarter and fender panel may be sealed by flowing liquid body sealer the entire length of the seam.

WHEELHOUSE—In production, a special seal is cemented into the opening (10) between the wheelhouse and the rear fender. Should further sealing become necessary, the opening may be filled with body sealer. Fill the upper part of the opening by working through the lightening holes in the drain gutter reinforcement (11) inside the trunk compartment. Fill the lower part of the opening by working from underneath the fender. The application of undercoating at this area will also assist in forming a more thorough seal against leakage.
