Correct Diagnosis Saves Time and Money Clutches

Clutch Pedal Linkage and Adjustment

23rd Series

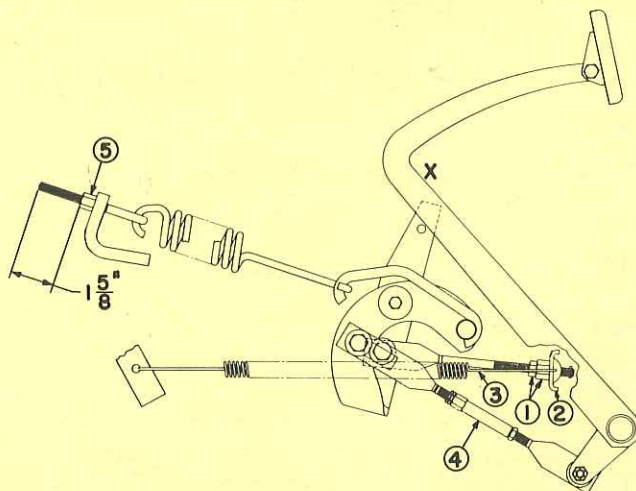
The clutch pedal linkage on 23rd Series vehicles differs from that of previous models in that the pedal pressure and the booster spring over-center point are variable. In previous models, both the pedal pressure and the over-center point were fixed.

The pedal pressure is governed by the setting of the booster spring eye bolt nut (5) in the accompanying illustration. On some of the previous models, an eye bolt and nut were used but the pedal pressure

The booster spring over-center point is controlled by the turn-buckle type pedal to relay lever link (4). With this adjustable link, the over-center point or, in other words, the point at which the booster spring actually "goes to work" and begins to pull the pedal downward can be accurately controlled. On previous models, a solid link was used and the over-center point could not be varied.

Clutch linkage adjustment on 23rd Series vehicles is as follows:

a. Check and if necessary adjust nut (5) to obtain the $1\frac{5}{8}$ " (approximate) dimension as shown.

d. Adjust link (4) so that the booster spring will continue to move the pedal downward after it has been moved one inch from its normal position against the toe board.

f. Adjust nuts (1) to obtain $1\frac{1}{4}$ " to $1\frac{3}{8}$ " free play at pedal pad.

g. Pull the pedal down so that the pedal pad contacts the toe board and hook a spring scale to the pedal arm at the point marked "X." Adjust nut (5) so that pedal will be held in this position when the scale registers a pull of seven pounds.

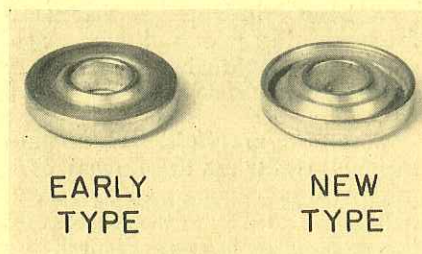
Figure 1

A new type of poppet valve seat is now being used in the Electromatic Clutch control valve. The early type and the new type valve seats are shown in figure 1.

This new valve seat may be installed in place of the earlier type when the seat has loosened and dropped out of position. The new seat has a taper on its outer diameter which allows it to fit tightly even if the bore into which it fits is oversize. It may be installed by tapping into place with a brass drift and a light hammer. Figure 2 shows a cross section of the solenoid and valve body with the new type seat in position.

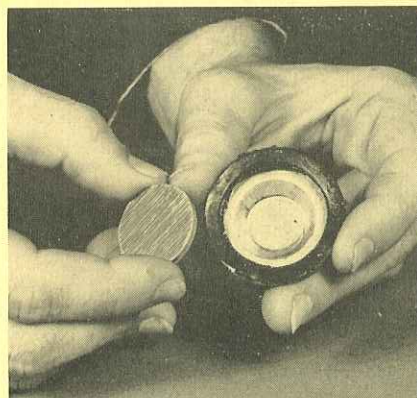
If the rubber and Silenite inserts are in good condition, probably the squeaks are caused by oxidation of the antimony-lead inserts. Prolonged contact with the air will cause the outer surfaces of most metals and alloys to oxidize if unprotected. Free oxygen in the air, for instance, will combine with steel to produce iron oxide, or rust, and since oxygen is also present in water, this goes for water, too. Antimony lead is no exception—its outer surface decomposes to a black colored oxide. The antimony-lead inserts are coated with grease for the same reason we paint steel—to slow down or inhibit oxidation.

To recondition the antimony-lead inserts, wedge the leaves apart, one end of each leaf at a time, and remove the insert and its retainer.

Take the insert out of its retainer, as shown in the accompanying illustration, and remove the black oxide from the insert bearing surface with a file. Examine the retainer. If it is distorted or if the rubber seal is damaged, it should be replaced. Now fill the retainer with grease and reinstall the insert in the retainer. After filing the antimony-lead oxide from the bearing surface of the spring above, reinstall the insert and retainer and remove the wedge. Repeat this process until all inserts and spring bearing surfaces have been reconditioned.
