PACKARD

Service Counselor

VOL. 23, NO. 8

AUGUST 1, 1949

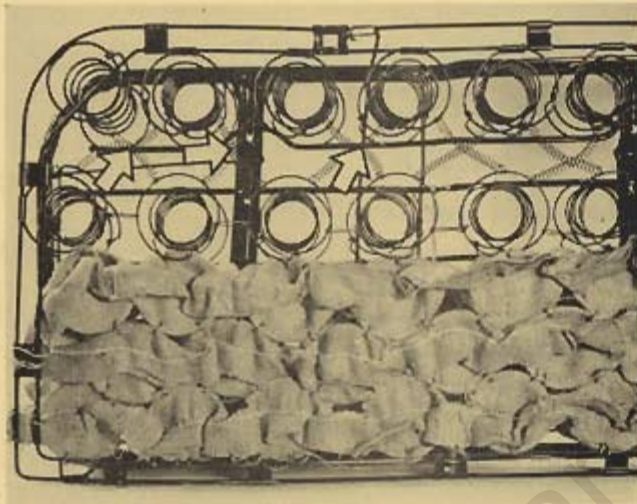
Fig. 1

Premature sagging or "breaking down" of front seat cushions usually is caused by improper positioning of the pad support, the omission of hog rings used to hold the various pads in place, or sprung or bent members of the seat frame assembly.

After the seat cover and the pads have been removed, the seat frame assembly should be checked and sprung or bent flanges, rims, or strainers should be straightened if they do not follow their normal contour. The coil spring cross ties, indicated by the arrows in figure 1, should be attached to the seat coils as shown.
