VOL. 12 No. 3

FEBRUARY 1, 1938

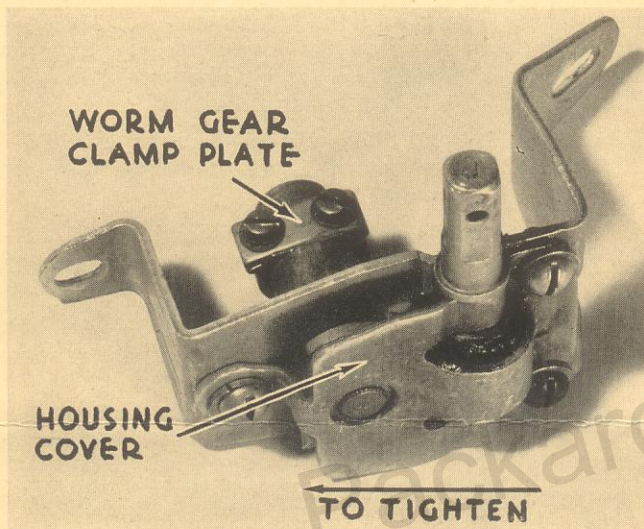
An adjustment is provided to take up back-lash in the front ventilating window of the Six and Eight.

The regulator housing cover which positions the worm in relation to the gear, is attached with three screws the holes for which are slotted to allow for adjustment. Moving the cover toward the single screw moves the worm toward the gear, decreasing the back-lash.

Remove the door and window operating handles and the door trim panel. Remove the two nuts from the studs holding the regulator assembly. Loosen the two screws in the worm gear clamp plate which hold the worm gear on the shaft, and lift out the assembly.

If the assembly does not come out readily, rotate the worm back and forth to take the tension off the worm gear shaft.

When tightening after the desired back-lash is secured, the two screws on the same side of the worm shaft should be tightened first, then the single one. This will hold the worm in against the gear. Tightening in the reverse order tends to move the worm away from the gear, increasing the back-lash.
