VOL. 13 No. 23

DECEMBER 1, 1939

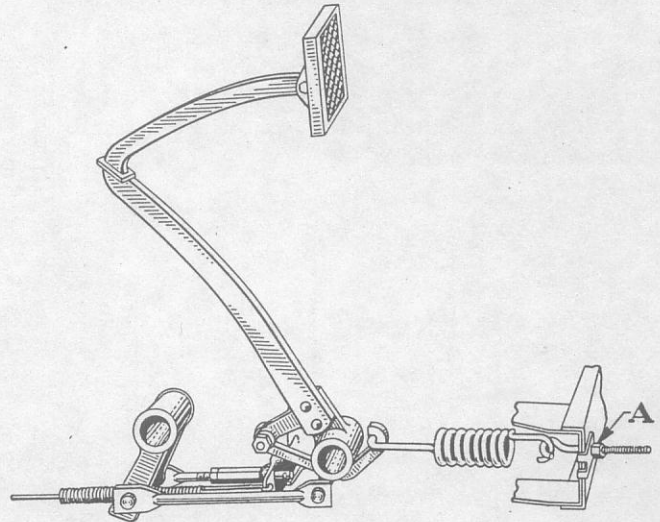
CLUTCH PEDAL ADJUSTMENT 18th Series

If complaints of high clutch pedal pressure are received on cars equipped with Borg and Beck clutches (see November 1, 1939, Service Letter), the pressure may be reduced somewhat by adjustment.

Model 1800 and 1801 cars, equipped with these clutches, are fitted with an assist spring on the clutch pedal the same as the Super 8's. The spring tension may be adjusted to supply more assistance, and thus decrease the pedal pressure, by turning up on the adjusting nut A. As the clutch pedal pressure is reduced, the sense of feel in the clutch pedal is reduced. The pedal pressure should not be reduced to the point where all sense of feel is lost.

The standard factory setting is 28 turns on the nut after the slack is taken out of the spring.
