General Service Manager,
PACKARD MOTOR CAR COMPANY

ECONO-DRIVE BEARING PRELOAD — 1700-1-2-3-5

HIGH SPEED MISS

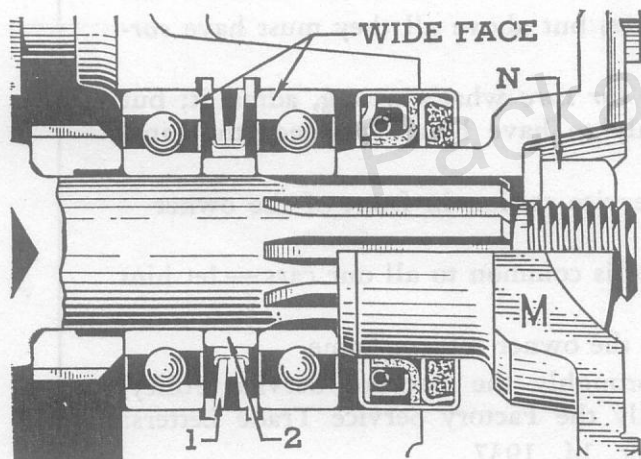
The Econo-Drive rear bearing mounting has been changed so that the preload will be applied by a spring washer assembly and solid spacer installed between the bearings rather than the manual adjustment previously applied by the collapsible spacer and tightening of the flange nut.

Units fitted with spring preload washers can be identified by the letter "M" stamped on the flat side of the universal joint flange.

The new spring washer assembly and solid spacer are now available through the Parts Department and should be installed in all Econo-Drive units that are disassembled for any reason. The following parts will be required:

When the above parts are installed the letter "M"— $\frac{1}{4}$ " high should be stamped on the flat side of the universal joint flange.

1. Remove rear bearing retaining snap ring, piece number 338478 from case.

2. Put spring washer assembly (1) in case. There is no front or rear to the washer but care should be used to see that the cotter pins in washer are not caught under bearing retaining snap rings.

3. Install rear bearing retaining snap ring. The spring washer must be compressed to install the retaining ring. Use a brass drift and tap ring down and into seat in groove.

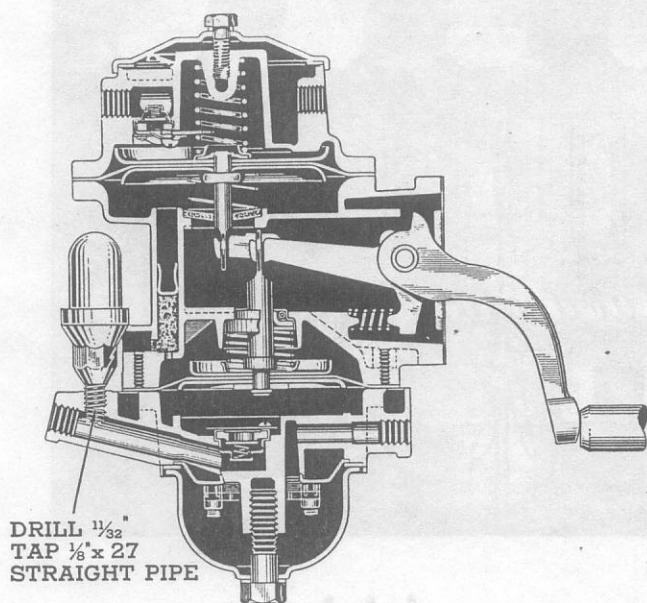
A high speed miss or cutting out at speeds in excess of sixty miles per hour after the engine has warmed up, which may be mistaken for vapor lock, is usually due to starvation or running out of fuel. This complaint is likely to be found only in cars not equipped with Econo-Drive.

This condition is due to failure of the fuel pump at high speeds to supply gasoline to the carburetor as fast as it is drawn out of the float bowl so that the level of the gasoline is gradually lowered to the point where the main jet is uncovered and the carburetor actually runs out of fuel.

The high speed capacity of fuel pumps which have been tested and found to be otherwise normal may be increased to supply a sufficient quantity of fuel by installing an air dome such as is used on the Super Eight. Air domes are carried

fuel pump is removed from the engine it is only necessary to drill out the cored recess in the discharge side, $\frac{11}{32}$ " inch, tap $\frac{1}{8}$ " x 27—straight pipe thread, and install air dome.
