## PACKARD WORKMANSHIP

## WHEEL CARRIER CLAMP BOLTS—HARDENED

# DIRECT-ACTING SHOCK ABSORBER NOISE—18th SERIES

## SUPER 8 OIL FILTER 18TH SERIES

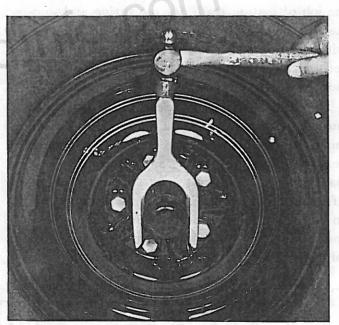
ST-5191 Wheel Hub Cap Puller \$1.40

The front wheel hub cap on the Model 1800 cannot be removed with ST-976 hub cap puller, as it is smaller than the caps on previous models. Check and see how many you require. Both your lubrication and brake departments should have one of these tools.

One of these tools will be shipped to each Distributer and Dealer who has given us permission to do so. Others please order.
