PACKARD MASTER SERVICEMEN!

COURTESY LIGHTS

19th SERIES

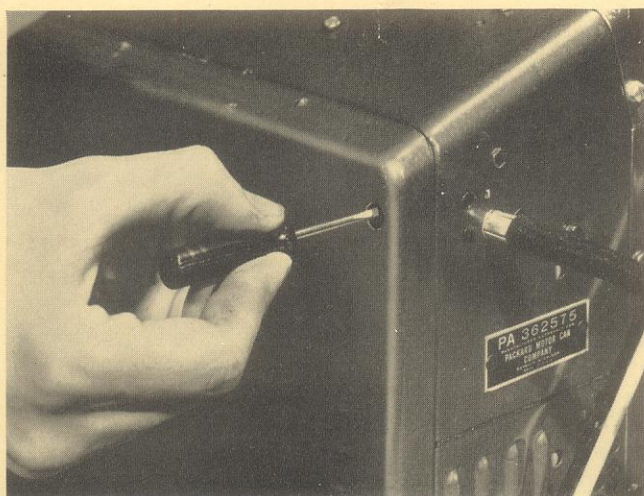
We have received a few complaints regarding the bottom edge of the radio chassis case coming in contact with the instrument panel and causing a squeak at this point. To overcome this squeak, loosen the two wing nuts which support the radio against the instrument panel. Insert a small piece of rubber or tire tape between the radio case and the instrument panel. Tightening up the wing nuts will squeeze this insulator between the radio and the instrument panel, preventing it from becoming dislodged.

Synchronize each radio with the antenna after both have been installed on the car. To do this simple operation, remove the chrome snap plug in the top right-hand corner of the radio case and rotate the adjusting screw with a small screw driver. Approximately $\frac{1}{4}$ turn to the right or left will be all that is necessary.

It is advisable to have the antenna fully extended and the car standing in a shielded spot while this adjustment is being made. Tune the radio to a weak station around 1400 kilocycles and adjust the antenna compensator until the maximum volume is obtained.
