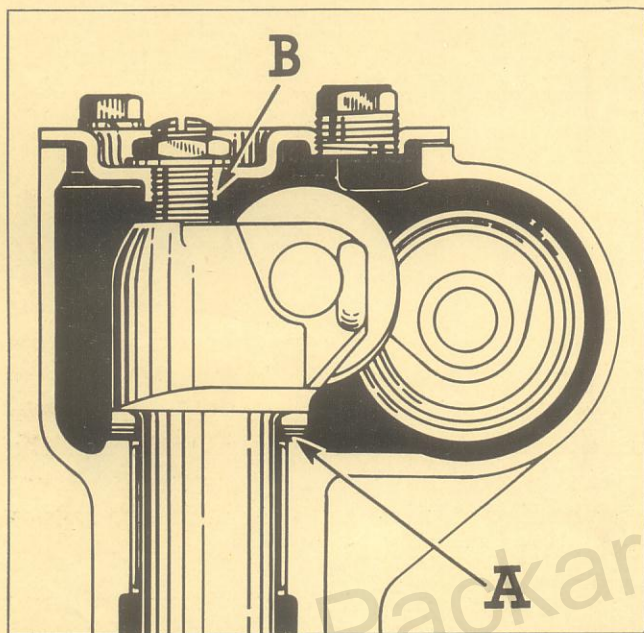
STEERING CROSS SHAFT

Some cases of difficulty have been experienced when installing a new steering worm and cross shaft in the 120, 120-B and 120-C.

This is usually due to the worm being slightly larger in diameter which crowds the cross shaft roller.

In cases of this kind it is necessary to install shims between the cross shaft inner bearing surface and the housing at "A."

In cases where several shims are used the outer surface of the cross shaft may bottom on shoulder "B." To get proper clearance, it is only necessary to file or grind off enough of this shoulder to allow proper adjustment.

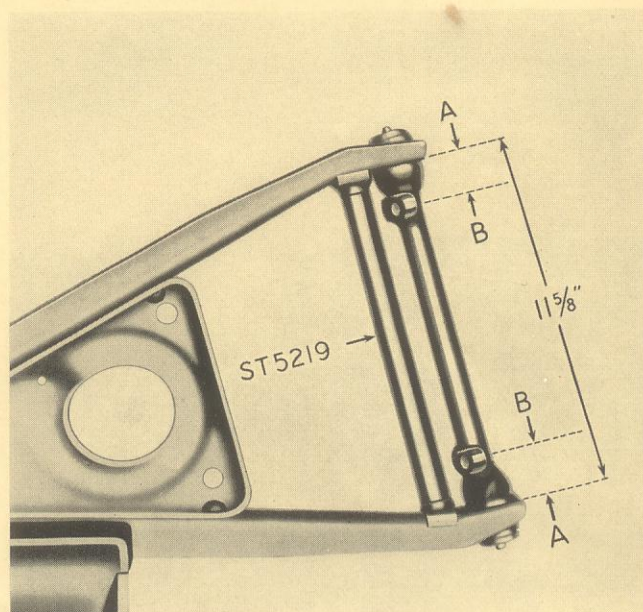
LOWER SUPPORT ARM ASSEMBLY — 20th Series Clipper

Recently we have had brought to our attention a noise noticeable when the car is brought to a stop or starting after a full stop has been made.

The noise heard resembles a heavy thud or shifting in the front end lower support arm assembly.

To correct, it is necessary to remove all 4 pivot shaft bolts and nuts, lower the inner end of the support arm, remove one of the outside bushings, install ST-5219 and spread the inner ends of support to $11\frac{5}{8}$ ", then tighten bushing which was removed, to working position.

Remove spreader and equalize distance between pivot shaft bolt holes on inner face, A to B, of support arm so that both sides are equal.

Again check distance between support arm inner face with spreader removed and both bushings tight. This measurement should now be $11\frac{1}{2}$ ". Reassemble to cross member. Complete same operations on opposite side.

Leave pivot shaft bolts loose enough to neutralize by lowering car and moving it up and down. Tighten, replace cotter pins and grease.

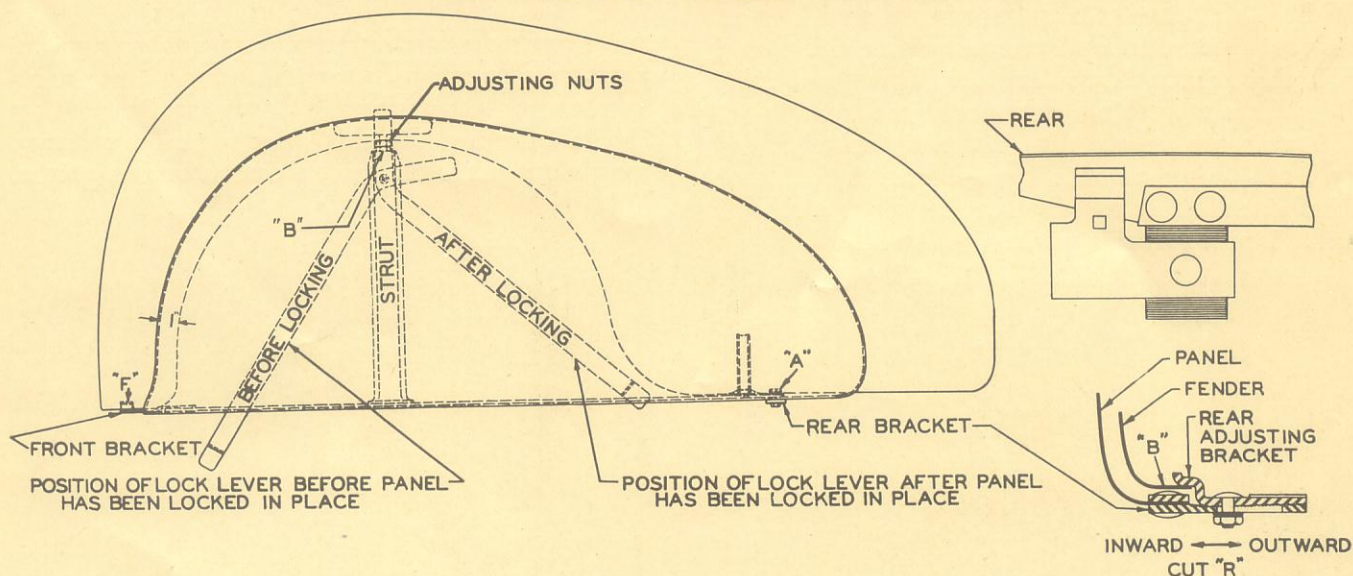
INSTALLING FENDER WHEEL PANELS

Caution—Before installing panels, be sure that adjusting nuts are not tight against top of strut, as shown at point "B". The adjusting nut should be only finger tight. If it is too tight, the shield will gape at the top.

Hook both front and rear adjusting brackets on bottom of panel over lower flange of fender as shown at "F" for front and cut "R" for rear and swing panel up against fender. Front edge of panel to overlap fender about one inch.

The crown in panel exerts sufficient pressure against fender to seal it securely in place. Rear adjusting bracket may be adjusted, to either increase or decrease the pressure of rear end of panel against fender. If there is too much pres-

sure, loosen rear adjusting bracket and move outwardly. If panel does not fit tightly, loosen rear adjusting bracket and move inwardly.

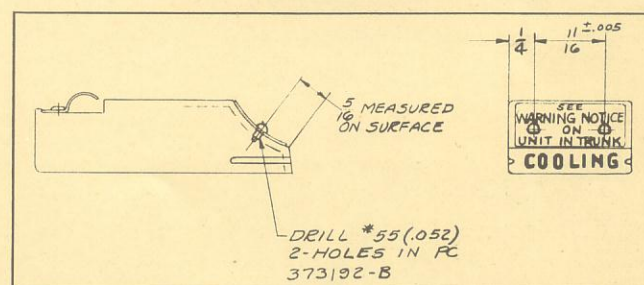
Because of defense restrictions, it is impossible to obtain an adequate supply of Freon for air conditioned equipped cars. Methyl Chloride will be used. This material was very generally used as a refrigerant for many years before Freon was developed. It is slightly toxic and contains a small percentage of odor identifier which will give adequate notice of leakage. Warning plates will be attached where the installation is made at the factory. One plate is attached to the Blower Motor Control Switch Knob and one to the Evaporator Case Assembly.

BECAUSE OF DEFENSE RESTRICTIONS THE ONLY GAS AVAILABLE AS A REFRIGERANT FOR THIS APPARATUS IS A POISONOUS GAS. IT IS SEALED AND THE PARTS THAT HOLD IT ARE WELL MADE. HOWEVER, THE USER IS CAUTIONED TO DISCONTINUE ITS USE IF A LEAK OCCURS AND THE OWNER, OPERATOR AND ALL OCCUPANTS OF THIS CAR EXPRESSLY ASSUME ALL RISKS FROM THE ESCAPE OF THIS GAS.

When Methyl Chloride is installed in the field, the warning plates should be obtained and attached.

When Methyl Chloride is used as a refrigerant, this fact and the information on the plates should be brought to the attention of the customer.
