WHAT YOU SHOULD KNOW ABOUT TIRES

BRAKE SQUEAK—120

FRONT WHEEL SUSPENSION—120 CASTER AND CAMBER ADJUSTMENT

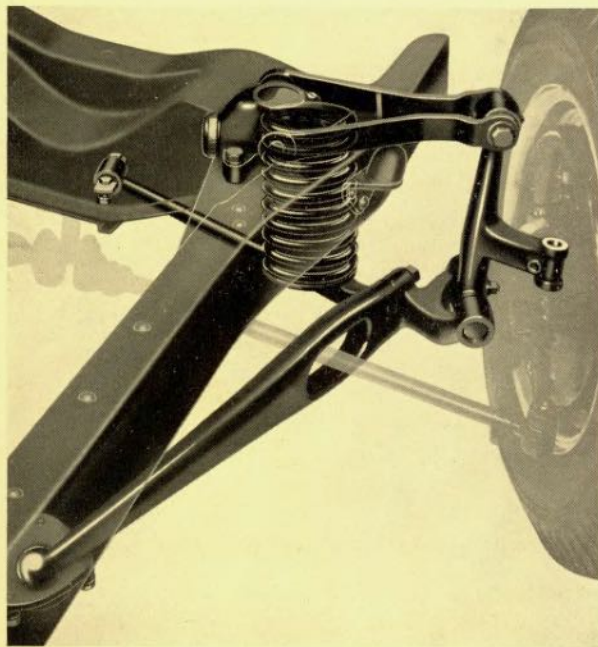
The desired camber angle is 1 degree with a permissible variation of $\frac{1}{4}$ degree plus or minus. Properly positioned, each wheel will have a camber angle between $\frac{3}{4}$ of a degree and $1\frac{1}{4}$ degrees, and the variation between right and left wheel will not exceed $\frac{1}{2}$ degree. Front wheel support upper bearing pilots, located in the outer end of the shock absorber arms, provide the adjustment means. One concentric and three offset pilots provide seven adjustment positions. Piece No. 303075 is concentric and provides central location of the bearing. 303076 is offset $\frac{1}{8}$ inch. 303077 is offset $\frac{1}{8}$ inch and 303078 is offset $\frac{3}{16}$ inch. The offset pilots are all reversible and may be used to increase or decrease camber angle. The length of the vertical wheel support is such that the $\frac{1}{16}$ -inch gradation of the pilots gives approximately $\frac{1}{3}$ degree change

in camber angle. It will be seen that camber angle within the specified limits can be easily obtained.

Occasionally we are advised of a tendency in certain cars to pull to the right or to the left. We believe this characteristic is definitely associated with camber angle, and our factory experience has been that the fault can be eliminated by bringing camber adjustment of both wheels within the specified limits. We urge that this procedure be followed before resorting to other expedients.
