## 22<sup>ND</sup> & 23<sup>RD</sup> SERIES TRUNK LATCH MODIFICATION

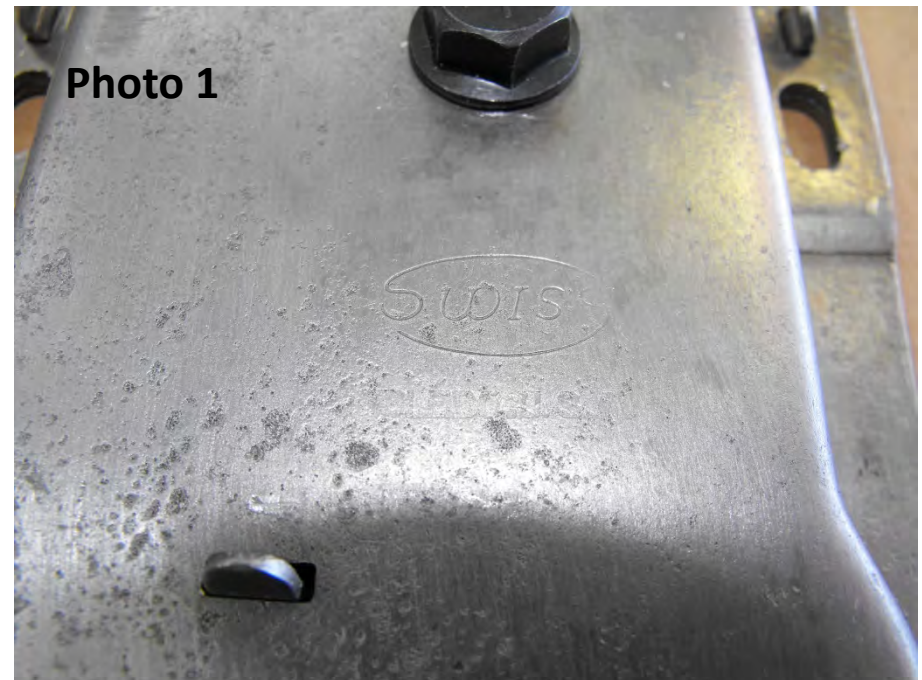
**Photo 1**

**Discussion:** Photo 1 shows a disassembled Ebay 'treasure' 22<sup>nd</sup> & 23<sup>rd</sup> series trunk latch. The rivet that acts as the latch pivot is the only component that is compromised during tear-down. This rivet is 5/16 inch diameter at both ends, but features a 3/8 inch diameter at the pivot. Both ends of the rivet were likely 'waffle headed' in one operation. Photo 2 shows a 'tear' in the sheet metal housing, likely a result of 'aggressive' forming 68 years ago. It is not a hole, only outer fibers of the material have torn. Photo 3 shows a tool used to re-install the cylinder lock clip. It is 1½ X ¼ 'band iron', the bent section should be 1 - 1½ long.

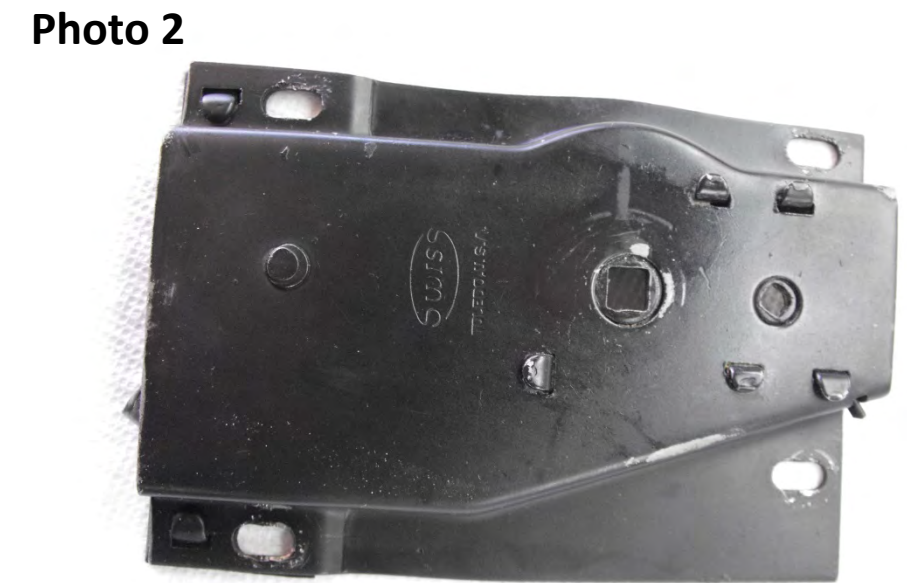
**Photo 2**

Note in Photo 2 the ‘pivot’ rivet is not waffle headed on the trunk side of the latch. The other end of the rivet is however waffle headed. The waffle pattern also appears to have some degree of variation. Four parallel marks and a cross pattern have been observed. It is unknown if the latch depicted in Photo 2 has ever been disassembled and re-riveted.

Variation in the end of the leaf spring has also been observed. Photo 2 shows the spring exiting the housing at essentially a right angle to the housing. A variation is that the spring end is folded-over quite close to the housing, and looks somewhat like the other seven tabs.

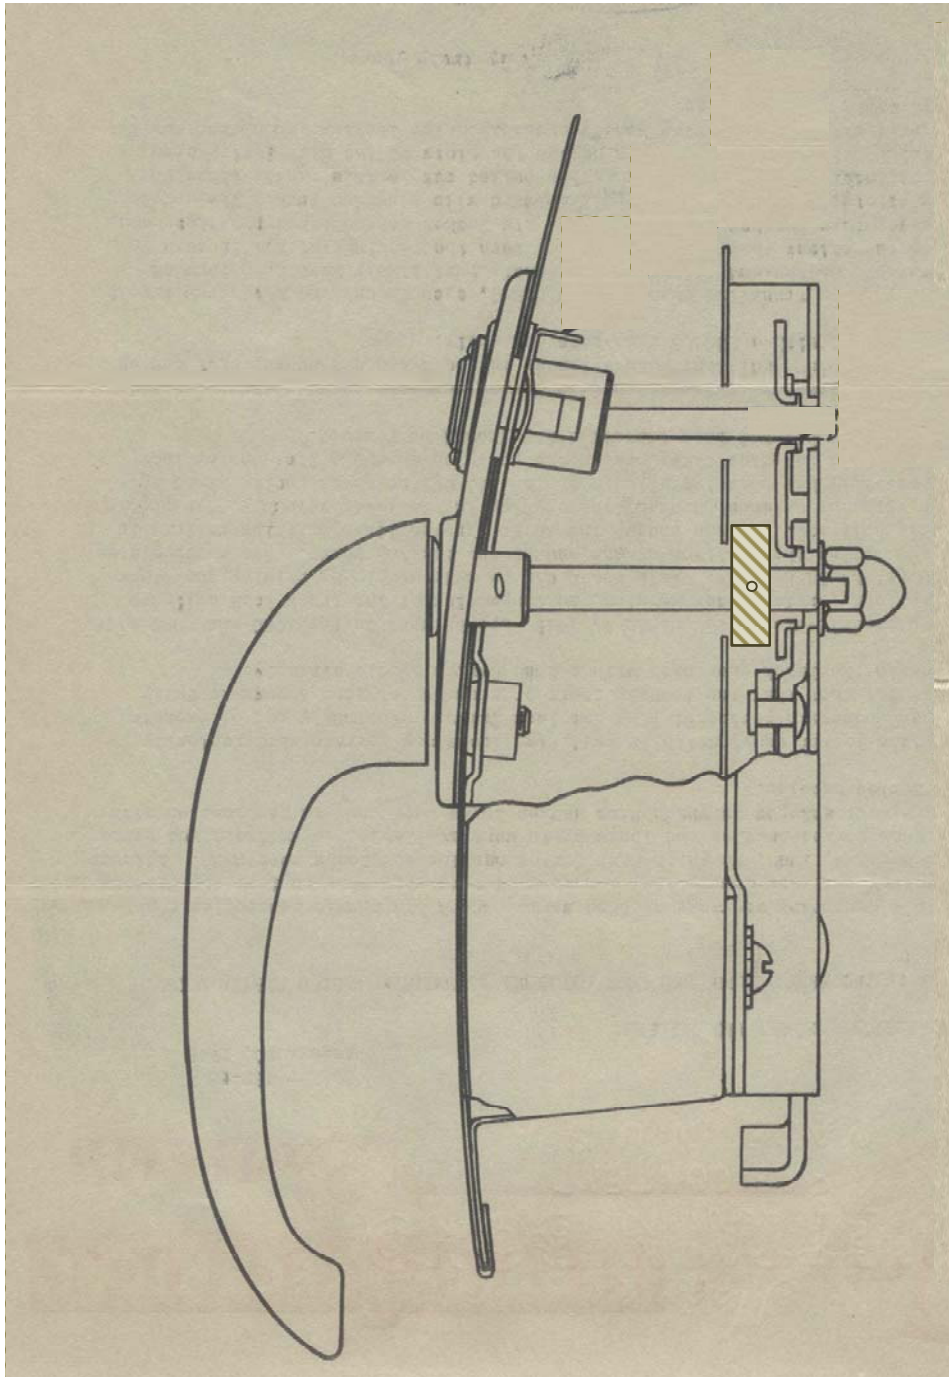
- CROSS-HATCHED ITEM IS A 'SET-SCREW' COLLAR THAT WORKS IN CONCERT WITH THE ACORN NUT TO EFFECTIVELY 'CAPTURE' THE SQUARE SHAFT.
- LOSS OF RETENTION BETWEEN THE HANDLE AND SQUARE SHAFT WILL NOT RESULT IN THE SHAFT FALLING OUT OF THE LATCH ASSEMBLY.

- THE COLLAR IS NOT VISIBLE WITH THE LATCH ASSEMBLY INSTALLED (I.E. HIDDEN IMPROVEMENT).
- THE ACORN NUT AND TAB WASHER ARE MODEL A FORD RUMBLE SEAT / TRUNK LID HANDLE COMPONENTS. THE 5/16 INSIDE DIAMETER COLLAR WAS PURCHASED AT ACE HARDWARE. THE HOLE IN THE COLLAR WAS HAND FILED TO FIT THE SQUARE SHAFT.

- SQUARE SHAFT 'PULL-OUT' FORCE DURING INSTALLATION IS AVOIDED BY MACHINING THE ACORN NUT SUCH THAT NUT 'BOTTOMS' ON SHAFT PRIOR TO CONTACTING THE LATCH ASSEMBLY (TAB WASHER IN-PLACE). A 'SELECT-FIT' SHIM WASHER (NOT SHOWN) ENSURES THE TAB WASHER REMAINS EFFECTIVE. AN ALTERNATE MEANS TO AVOID EXCESSIVE TORQUE WOULD BE TO 'FINGER' TIGHTEN AN UNMODIFIED NUT.

- WITH ABOVE CONSIDERATIONS THE 'PULL-OUT' FORCE APPLIED TO THE SQUARE SHAFT DURING INSTALLATION WILL MINIMIZED, AND THE PROBABILITY OF SHAFT 'FALL-OUT' IS SIGNIFICANTLY REDUCED.
