PACKARD

Service Counselor

VOL. 21, NO. 21

NOVEMBER 15, 1947

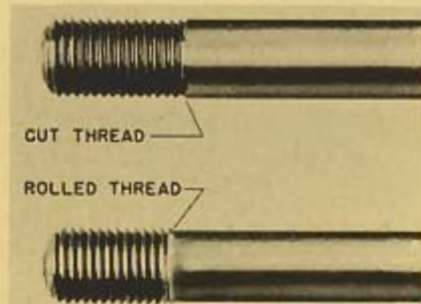
The stud type may be determined by the shape of the first thread as shown in the illustration. The threads of the rolled type are larger in diameter than the shank of the stud. In the cut thread design the thread diameter is the same or less than the diameter of the shank of the stud.

To reduce the possibility of water leaks around the cylinder head stud, a new stud with rolled threads is now being used in production.

These studs are not interchangeable with the older cut thread type and may be used only in engines having the new design installed at the Factory.

The new studs are carried under piece number 403255.

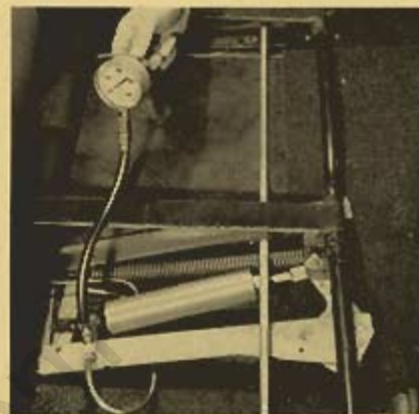
The illustration shows a gauge for checking the fluid pressure in the lines on the 1948 Convertibles.

Consult the Service Manual, Section 1, The Hydraulic System of the 1948 Convertible, for details and pressure. The gauge may be installed in the lines at any accessible point.

Caution: Care must be exercised to prevent fluid from damaging trim or finish.

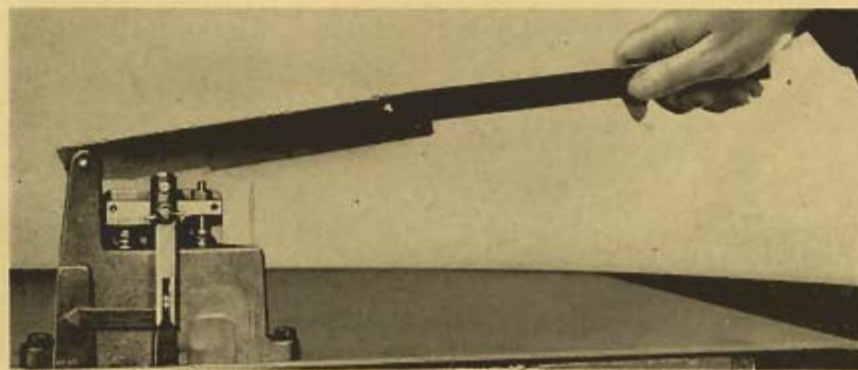
The purpose of this tool is to check the leak-down rate of hydraulic valve lifter assemblies. All hydraulic lifters should be checked when removed for faulty operation. Fill reservoir with No. 1 grade kerosene. Release the ball check on the master unit and pump the unit until all air is removed and the unit is filled completely.

Insert the master unit in the left socket of the tool and place the unit to be tested in the right socket. Rest the handle of the tool on the beam pilot and set the indicator pointer to zero. Press down several times on handle and note movement of pointer. If pointer goes down, the leak-down rate of the lifter being tested is greater than

the master unit and should be discarded. If the pointer stays at zero or goes up, the lifter is satisfactory.

The Hydraulic Valve Lifter Tester, tool number J-1297-B,
