# Service Counselor

PACKARD MOTOR CAR COMPANY

VOL. 24, NO. 5

MAY, 1950

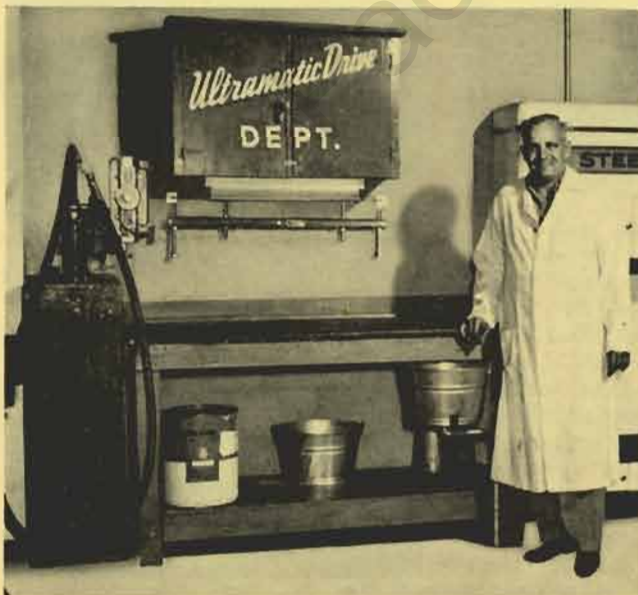
J. Earl Waters, Dealer in St. Petersburg, has done an outstanding job on this showmanship of Ultramatic Service and in a very practical way. Here are two pictures of his Ultramatic Drive department with Bob Gott who operated it. Notice the draining, cleaning and refilling

facilities. A complete set of special tools is kept in a clean, safe, handy locker. The lighted bench is masonite covered for protection of parts.

Note, too, the convenient location of all training material and bulletins pertaining to the Ultramatic Drive. It's important to keep this information up to date and to have it handy for quick reference.

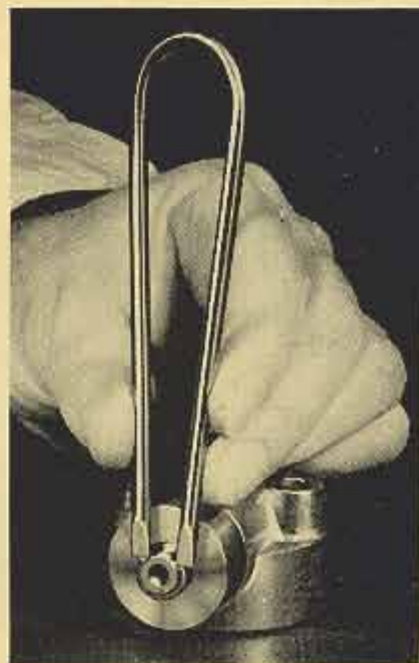
Fig. 1

To remove the ring, pull the vent valve outward so that the ring is out of the recess in the flyweight. Place the ends of the tool on the ends of the ring, as shown in figure 1, and then strike the top of the tool.
