Service Counselor

PACKARD MOTOR CAR COMPANY

JULY, 1953

Service Replacement Engine

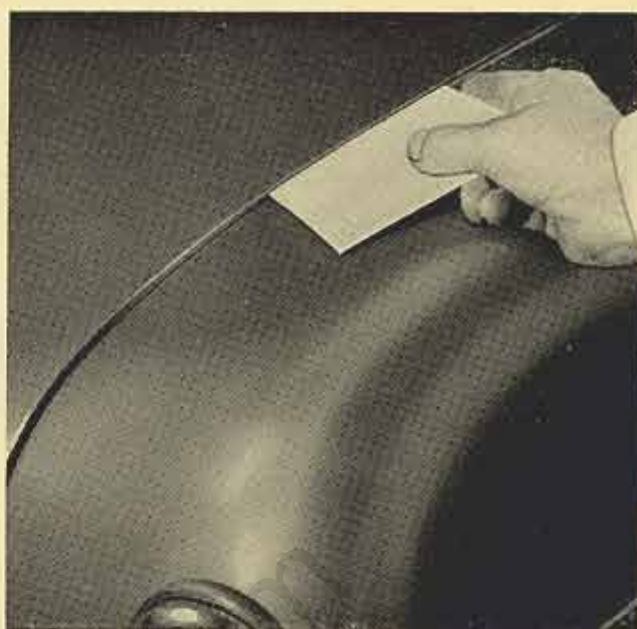
Fig. 1

Before water testing for trunk lid leaks, it is suggested that a trunk lid to weatherstrip contact check be made all around the lid with a thin paper card as shown in Figure 1 to see if the lid is bearing tight on the weatherstrip at all points.

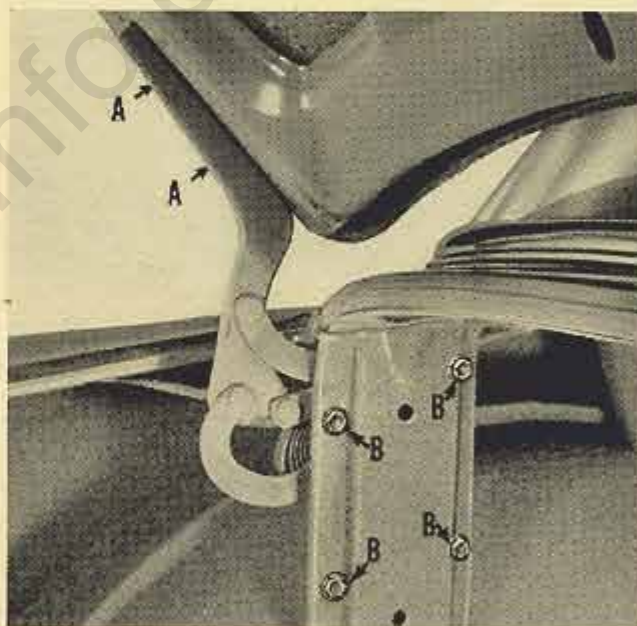
Fig. 2

1. Loosen the cap screws "A", Figure 2, on both hinges and shift the lid forward or back to obtain correct clearance between the lid and the body panel. Retighten the cap screws.
2. Loosen the cap screws "B", Figure 2, and shift the hinges up or down to obtain lid alignment so that the contour of the lid is in line with the body panel. It is easier to have a man inside the trunk to tighten the screws "B", while the trunk lid is closed and held in position.
3. Again check the lid to weatherstrip contact with a thin paper card as shown in Figure 1. If any low places are found along the sides or front, they can be raised with a jack as shown in Figure 3.
