VOL. 10 No. 23

DECEMBER 1, 1936

NEW YORK DE LUXE SERVICE

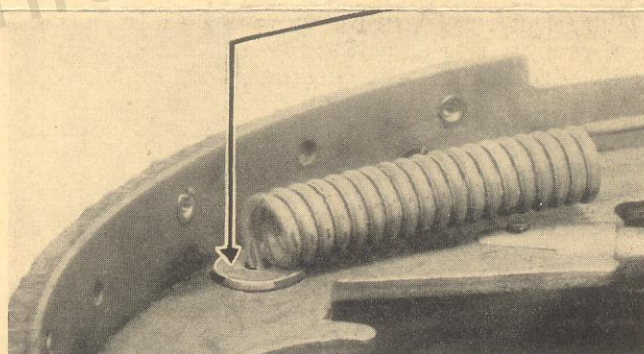
This squeak occurs as the brakes are applied and is caused by the relative movement of the shoe retracting spring and the push rod that connects the hydraulic cylinder to the shoe, and sounds like the shoes rubbing on the backing plate.

This squeak has been corrected in production by placing a $\frac{1}{16}$ " thick washer between the spring and the shoe web and passing the hooked end of the spring through the hole in the washer and then through the hole in the shoe. The same correction can be made in the field when this condition occurs.

When attaching the retracting springs to the anchor pin, the primary shoe spring must be attached first and the secondary shoe spring second, so as to raise the secondary shoe retracting spring to clear the reinforcing plate at the top end of the secondary shoe.

The illustration shows the washers properly installed.

The washers used are standard $\frac{3}{16}$ " finished washers $\frac{5}{8}$ " O.D. x $\frac{1}{16}$ " thick which you can buy locally. Should you wish to order from the factory Parts Department specify No. 3867 washer.

When reassembling, after the installation of the washers, it is important as a precautionary measure that the shoe bosses on the backing plate be liberally coated with Lubriplate to insure against a squeak developing later at these points.

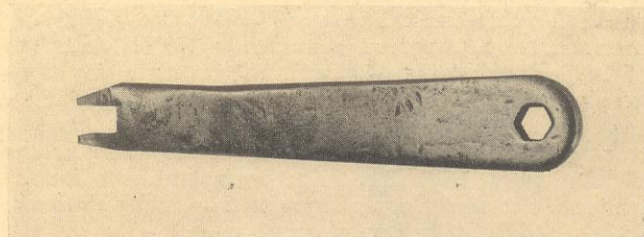
Tool No. ST-5089—Price \$.60

Instrument board headlight switch wrench is another important tool. It is made to conform to the shape of the headlight switch nut. It is very difficult to remove the switch without this wrench.

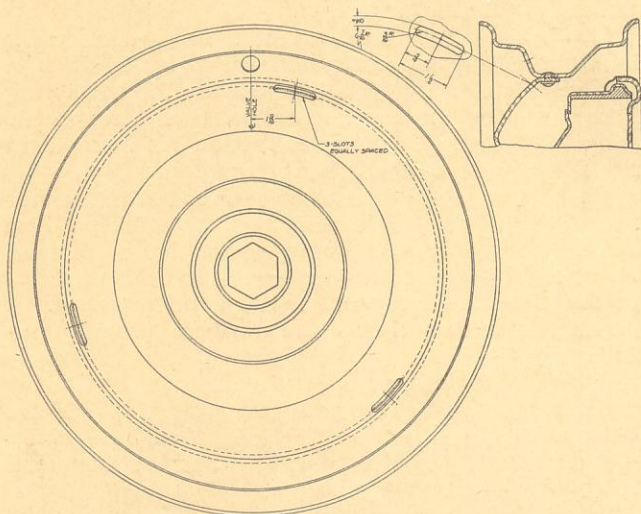
Such installation may only be made if slots are cut in the wheel disc to permit the attaching strap to go through. The illustration shows the proper location,

spacing and size of slots which may be cut in wheels for this purpose. Locating the $\frac{3}{8}$ " x $1\frac{1}{2}$ " slots as shown will keep them high enough so that the brake drum will not interfere with the strap when installing the emergency chains and will reduce to a minimum the knife edge effect of the outer edge of the slot which would have a tendency to cut through the strap.

After cutting the slots, all edges should be neatly beveled and the hole touched up with matching paint to prevent rusting. **DO NOT CUT MORE THAN THREE SLOTS** as shown. To do so would seriously weaken the wheel.

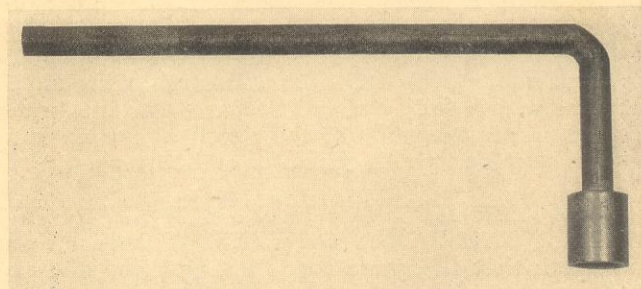
Tool No. ST-983—Price \$2.00
Model 1500—1507—120's—Six

A special right angle socket wrench for removing the brake master cylinder filler plug is illustrated. Since you don't have to remove the front floor boards you save about 15 minutes.

Remove the round plug in the front floor boards and insert the special wrench through the opening. Remove the cylinder filler plug, and fill the master brake cylinder with fluid.

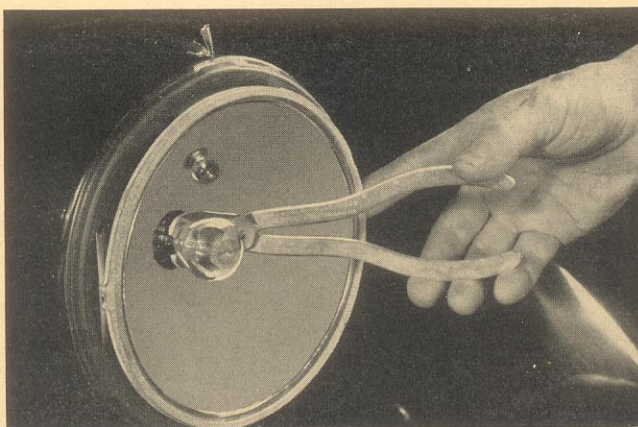
Tool No. ST-996 Price—\$.70 All Models

Anyone who has ever tried to remove lamp bulbs will recognize the value of this tool. Why risk cut fingers or scratched reflectors, when bulb pliers makes the removal quick and easy?

These pliers grip the base of the bulb and allow it to be firmly held for installation without any danger of the bulb glass being broken.
