# NOW, WHY DIDN'T SOMEONE TELL US WINTER WAS COMING?

### Accessory Display-WHERE and WHY

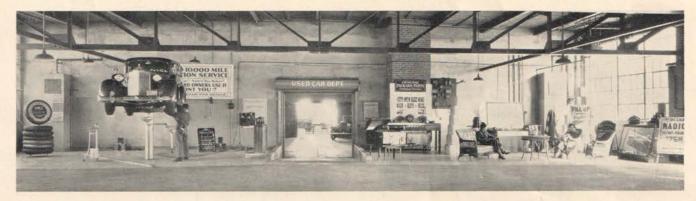
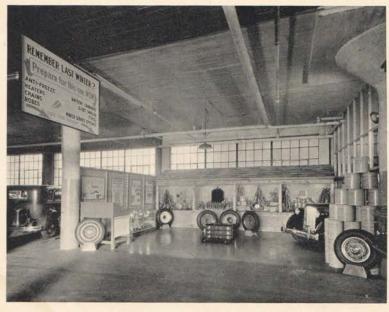
There is another thought which pertains to the safety of the material used and the cleanliness of the display. One of the illustrations which we use answers this problem in nice shape. Mr. Medlicott, Manager of the Springfield Branch, sent us the picture, indicating credit should go to Mr. Isham.

The description he gives indicates that the store is

made of pine with compartments lined with ply-wood. It is finished with silver gray acid stain with a dull varnish coating. The roof is of multi-colored asbestos shingles, and the display is spot lighted.

The other displays shown illustrate the advantage of the proper location with regard to the entrance and the use of new car display in the Service Department. These displays were worked out by the boys in Stamford and Chicago.

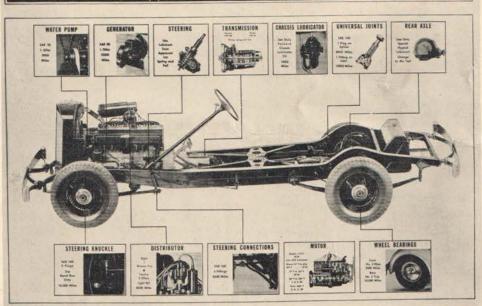
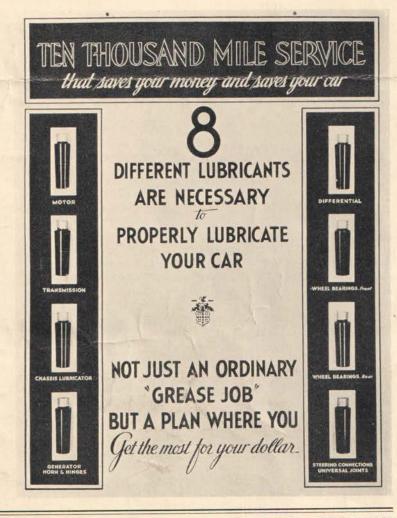
DISPLAY
MATERIAL
THAT WILL
HELP YOU SELL
10,000 MILE
LUBRICATION
AND
INSPECTION
SERVICE
TO MORE OF
YOUR
CUSTOMERS

We now have available a number of posters for displaying samples of the different oils used in lubricating Packards.

This is finished on heavy cardboard in black and red, and matches in design the lubrication chart which we also illustrate. These pieces will assist in promoting lubrication business, and are also sales aids in selling lubrication agreements.

The lubrication chart is priced at 50c, and is 32 ½ " in width x 44" in length. The chart for holding the sample lubricants is the same size and is also 50c. The tapered bottles with metal caps are supplied with wires for attaching, and these are 10c each.
