Service Bulletin

NO. 321

SOUTH BEND 27, INDIANA

Studebaker and Packard Clipper

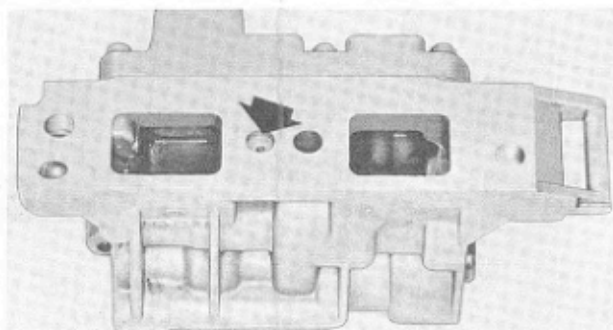
Fig. 2

IDENTIFICATION OF CONTROL VALVE ASSEMBLY AND GOVERNOR - FLIGHTOMATIC TRANSMISSION - 1957 GOLDEN HAWK AND PACKARD CLIPPER MODELS
