Service Bulletin

NO. 340

*Studebaker and
Packard*

SPEEDOMETER CORRECTIVE SERVICE

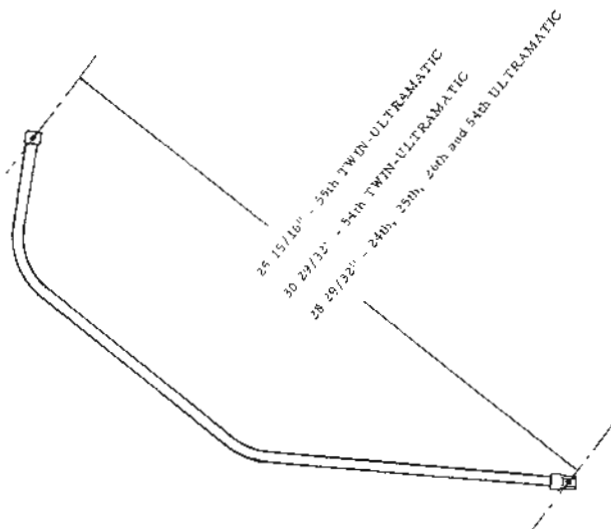
Fig. 6

Because of the shape of this rod, it is difficult to determine if it is bent. Its function is to control throttle pressures, clutch engagements and upshifts. Therefore, it is very important that the rod is of proper length. Figure 6 shows the manner in which the rod should be checked and the proper lengths for the various models.
