## Service Product Report Forms

### Front Wheel Bearing Adjustment All Models

## Clutch Fails to Release Properly

## Intake Manifold Drain for Custom Eights

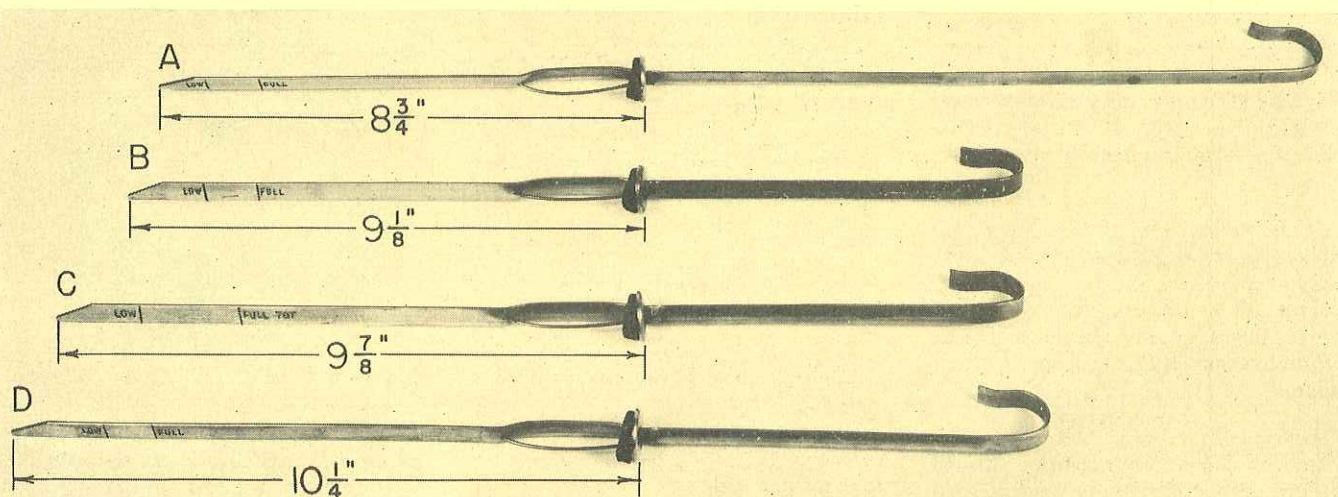
The accompanying illustration will serve as a ready reference to identify the oil level indicators used in 22nd Series engines. The dimensions shown are approximate since the cup shaped washer may be shifted slightly, which results in a slight variation in the measurement.

A—Taxicab and Export Six  
B—Eight and Super 8 with Suffix Letters A-C or None

C—Eight and Super 8 with Suffix Letters CD-CE-D-E  
D—Custom 8
