# Service Counselor

PACKARD MOTOR CAR COMPANY

VOL. 24, NO. 9

SEPTEMBER, 1950

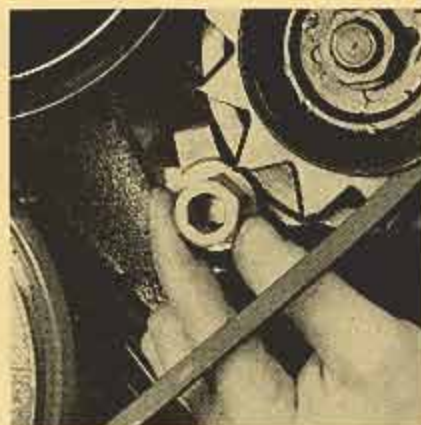
Fig. 1

On previous models, the proper belt tension is determined by applying finger pressure to obtain approximately  $\frac{1}{2}$ -inch deflection of the belt between the generator and water pump pulleys. This deflection method has been found to be inaccurate when applied to 24th Series design belts and the following torque method should be followed to obtain proper belt tension.

1. Loosen the two generator bracket to generator screw nuts two or three turns.
2. Loosen the generator adjusting strap to generator screw.
3. Loosen the generator adjusting strap to water pump screw.
4. Place the tool J-4714 over the head of the generator bracket to generator front screw and rotate the tool clockwise until the arm of the tool contacts

the edge of the generator drive end plate. See figure 1.
