# SERVICE Counselor

PACKARD MOTOR CAR COMPANY

VOL. 26, NO. 3

MARCH, 1952

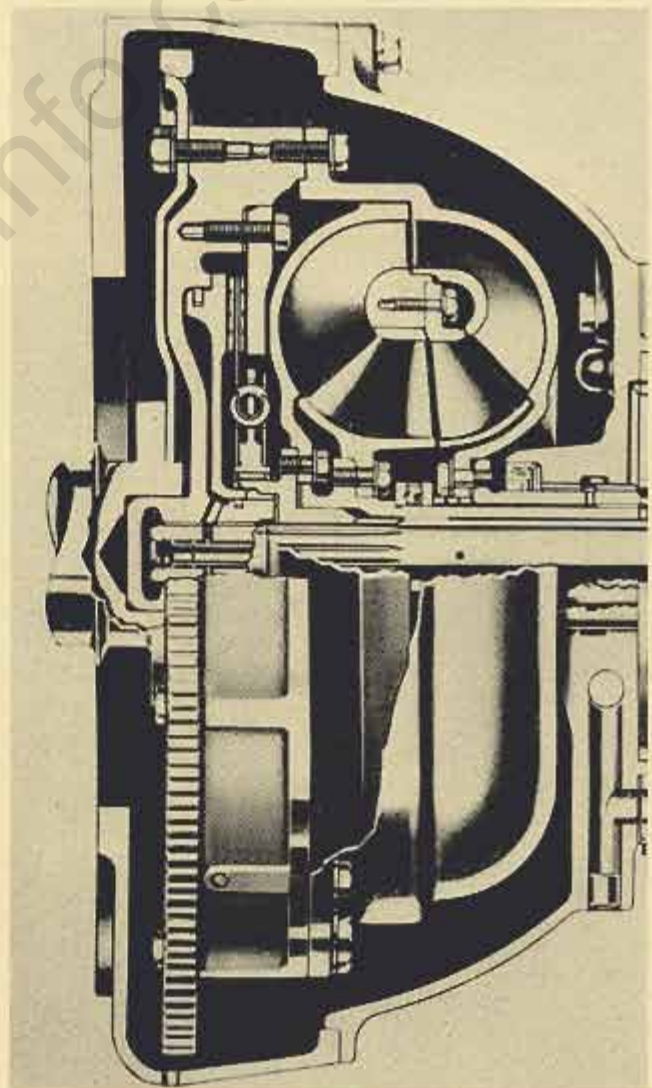
Fig. 1

The newly designed torque converter assembly has the working surfaces improved by providing a smoother finish, resulting in smoother performance and increased torque output.

A most important change in the new converter assembly is the new direct drive clutch assembly, which gives smoother engagement, more positive release on coming to a stop, definite and quicker release on kick-down, and less drag, which improves converter performance.
