PACKARD MOTOR CAR COMPANY

VOL. 28, NO. 10

OCTOBER, 1954

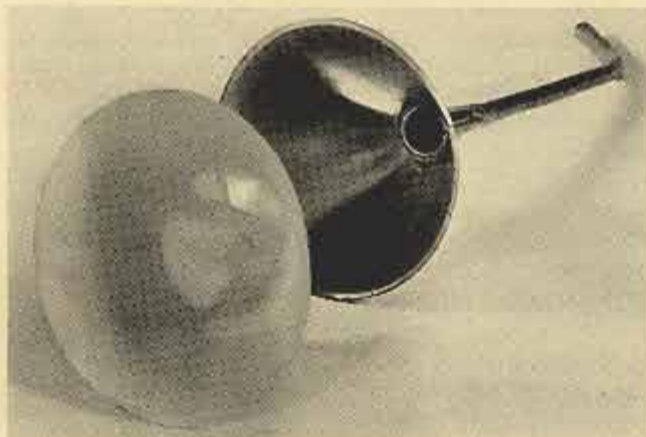
Illustrated is a practical and inexpensive tool which can be made up in your shop for filling the Gear Start Transmissions.

Bend a piece of $\frac{5}{8}$ " O.D. copper tubing approximately one foot long to a 45° angle as shown and solder it to a funnel.

A fine mesh paper paint strainer placed in the funnel provides a good method of straining the fluid. A new strainer should be used at each filling.
