PACKARD MOTOR CAR COMPANY

## counselor

VOL. 28, NO. 3

MARCH, 1954

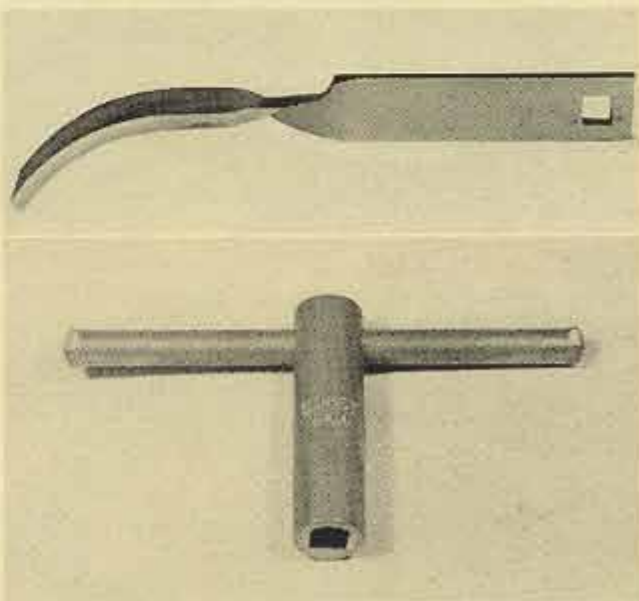
Fig. 1

Illustrated are two air conditioning system tools, Fig. 1, that are required when removing and replacing the compressor.

The compressor must be removed when it is necessary to remove the cylinder head for any reason; therefore, all Dealer Service Stations should be equipped with these two tools.

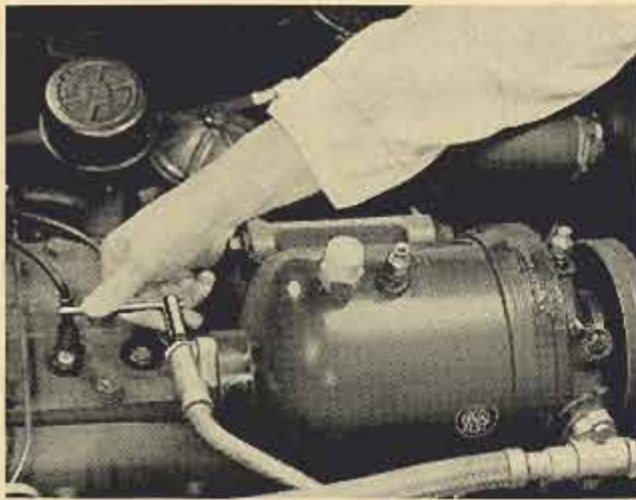
Fig. 2

The  $\frac{1}{4}$ " Liquid Valve Key J-5427 is used to shut off the high and low pressure valves at the compressor, Fig. 2. The Compressor Belt Tension Tool

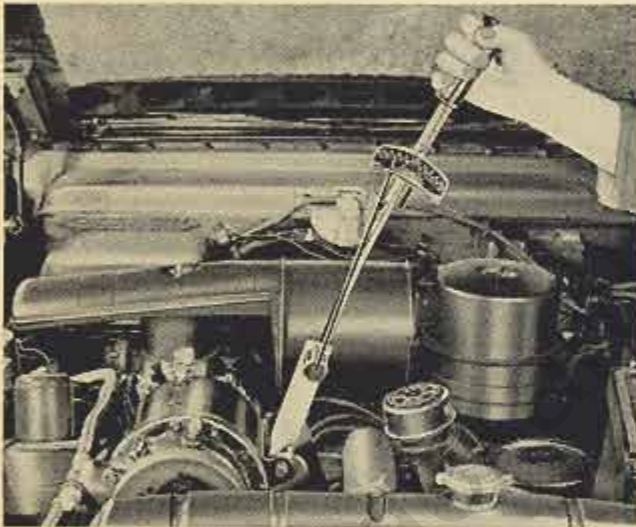
Fig. 3

J-5577 is used with a 100 ft. lb. torque wrench to properly adjust belt tension, Fig. 3.

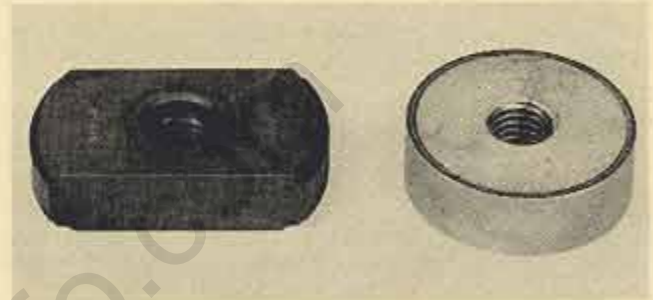
Due to certain design changes in the 54th Series differential housings, two additional tools are required to properly service the 1954, 54th Series differential assemblies.

These two tools are used only in removing the pinion bearing cups. They are used in conjunction with previously released differential tools as described and illustrated in Service Counselor, Vol. 27, No. 8, August 1953.

The tool on the left in the illustration is used to remove either the 25 or 40 degree rear pinion bearing cup. The tool on the right is used to remove the front pinion bearing cup.
