SERVICE COUNSELOR

PACKARD DIVISION

STUDEBAKER-PACKARD CORPORATION

FEBRUARY, 1956

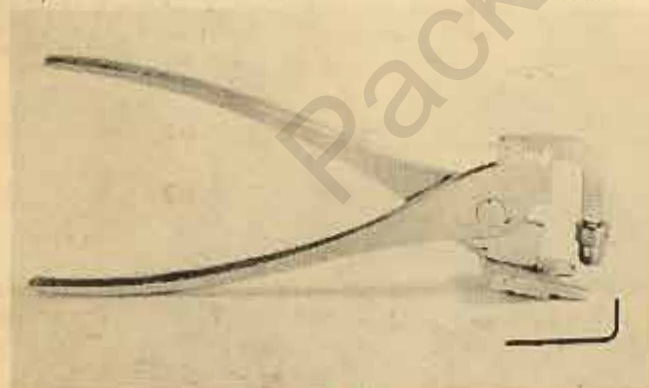
Fig. 2

Figure 2 illustrates the new hydraulic tappet Checking Tool J-5978-A that will test either type tappet.

If you previously purchased J-5978 Checking Tool you can bring the old tool up to date by ordering the Adapter Kit (figure 3) and grinding down the lower jaw of the old tool as shown by the arrow in figure 4. Grind the two ears of the lower jaw down to a $5/32$ " thickness and back $5/8$ " as shown.

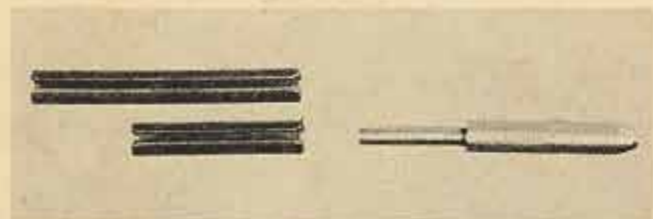
Removing and installing the roll pins in the power seat assembly can be very difficult without the proper tools.

Illustrated is an inexpensive tool which can be made up in your shop using 5/16" cold roll stock.

The small diameter end should be 1 inch in length and 3/16 inch in diameter with a square shoulder at the large diameter as shown.

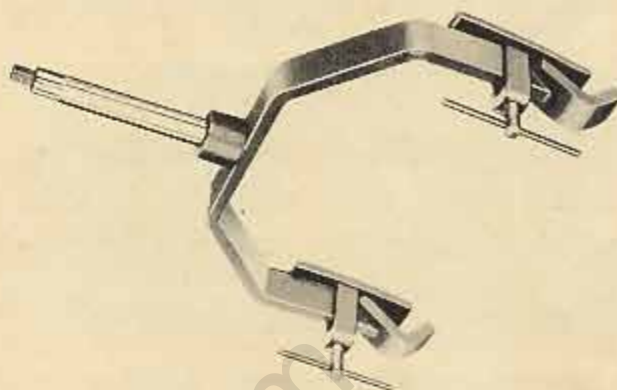
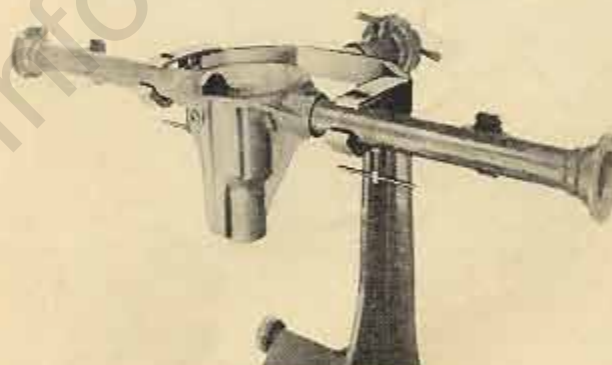
Illustrated is the Rear Axle Holding Adapter, designed and supplied by K. R. Wilson Inc. for holding the 1956 rear axle assembly while it is being serviced.

The adapter permits the use of the standard K. R. Wilson Engine Stand to safely hold the rear axle unit. The axle assembly may be rotated to any desired position while installed in the adapter on the stand.
