SERVICE Counselor

PACKARD-CLIPPER DIVISION
OF
STUDEBAKER-PACKARD CORPORATION

VOL. 30, NO. 5

MAY, 1956

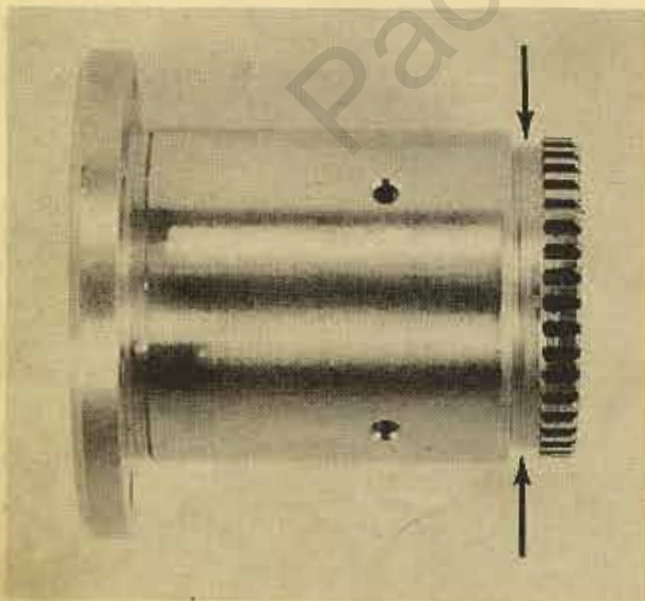
Fig. 4

New rotors with 40 splines and front pump assemblies with 40 spline rotors have been released for service replacement and are listed for your ready reference.

The pump assembly listed above has the oil passage in the front side of the body and the rotor has 40 splines, therefore it will be necessary to drill six $\frac{1}{8}$ " holes evenly spaced through the annular groove just back of the splines in the converter shaft to provide an oil passage to the direct drive clutch. "See arrows figure 4." This also applies when replacing the rotor assembly. Be sure to remove burrs from edges of $\frac{1}{8}$ " holes and internal bushing after drilling.
