VOL. 10 No. 13

JULY 1, 1936

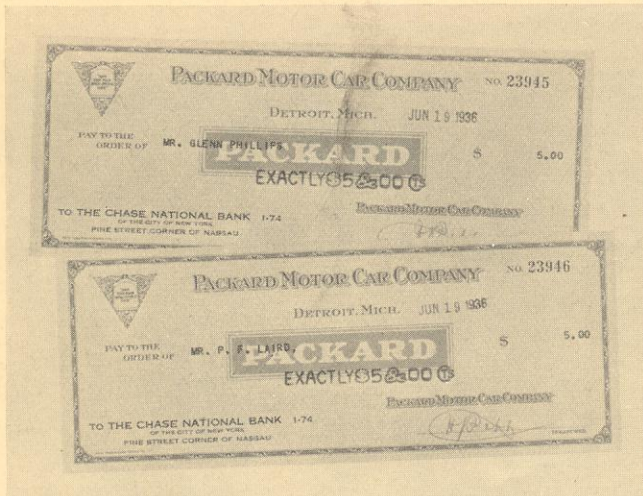
Awards were made to Mr. Glenn Phillips of Earle C. Anthony, Inc., Los Angeles, California, for a tool which he designed to remove the front hub caps from Models 120 and 120-B. From Mr. Phillips' idea a tool has been developed that will remove the hub cover as well as the cap.

An award was also made to Mr. P. F. Laird, Shop Superintendent, Earle C. Anthony, Incorporated, Oakland, California, who comes across with an inexpensive tool for installing the 120 and 120-B oil pump. The tool consists of a long tee handled pilot having slots at either end formed to engage the slots in the drive ends of the oil pump and distributor.

tor drive slot with upper end of tool and oil pump drive slot with lower end of tool. 4. Turn distributor rotor to No. 1 firing position as previously noted. 5. Slip oil pump up into place engaging drive gears. 6. Check distributor to see that rotor arm is in No. 1 firing position as previously noted. If not, disengage oil pump and rotate one tooth right or left until, with oil pump gears in mesh, distributor rotor is in proper position as previously noted. 7. Bolt oil pump in place. 8. Remove distributor and tool. Replace distributor.
