## WINDOW DRAFT ELIMINATION 120 - 120B

## DISTRIBUTOR—PACKARD TWELVE

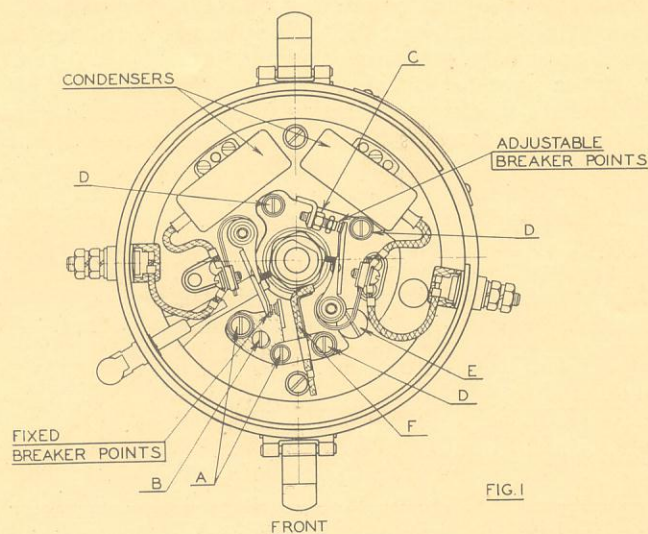
The maximum gap for the breaker points should be .020". This adjustment of the fixed points is obtained by loosening the two screws "A", Fig. 1, and moving the breaker point in or out by the eccentric screw "B". After obtaining the correct gap tighten screws "A". The gap adjustment of the adjustable points is obtained by loosening the point lock nut "C", Fig. 1, and screwing the point in or out as needed. After adjusting and the points are locked in place, recheck the point gaps to be sure they are exact to standard.

Whenever new points are installed or the old points adjusted, it is necessary that the two sets of points be synchronized so that the adjustable points fire  $26\frac{1}{2}^\circ$  after the fixed points and the fixed points will fire  $33\frac{1}{2}^\circ$  after the adjustable points. This is done by loosening the three screws "D" which hold the breaker sub plate on which the adjustable points are mounted and rotating the sub plate by the eccentric screw "E", Fig. 1. After obtaining correct synchronization, tighten the screws holding the sub plate and recheck.

Whenever new breaker points have been installed or the old points adjusted and synchronized it is impor-

tant for best performance of the engine that the distributor be retimed.
