1. Description of Issue & Service Letter guidance
2. Parts List observations
3. Rebuild notes and photos
4. Additional Assembly Information

1: Description of Issue

Packard acknowledged an issue of a driveline vibration that occurred in 1940 R9 overdrive equipped vehicles, observed only when the overdrive system is active. The excerpt from the letter, below, offers four options to address the vibration, each of which focuses on causes from within the overdrive unit itself. While Packard designed and built its own transmissions, the overdrive unit was designed and manufactured by Borg Warner, as were the prior R6 overdrive for 1939, the R11 overdrive from mid 1948 on and versions used by many of the other car manufactures. Although Packard's first assumption of cause of the issue was directed at the overdrive unit, ultimately Packard identified the cause to be within its own transmission as the explanations below will show.

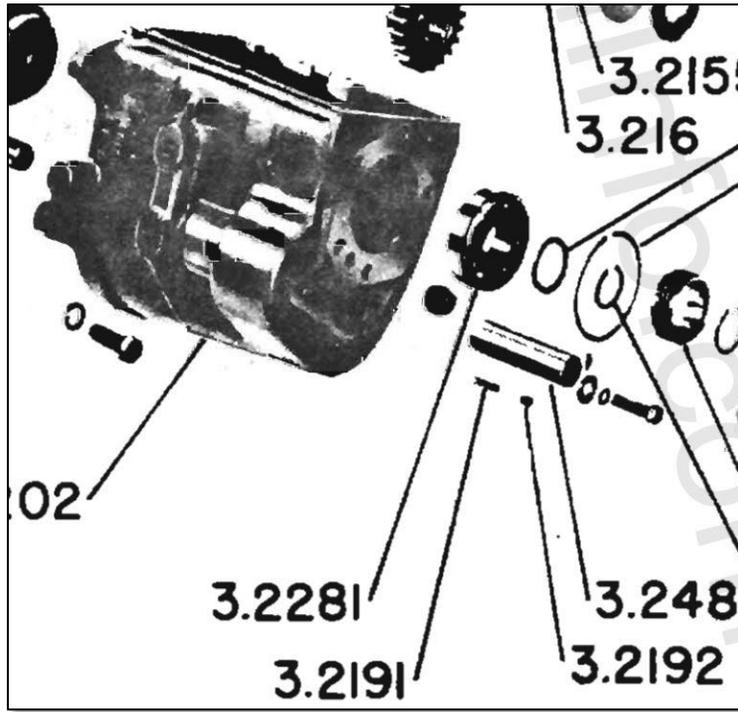
Figure 7: Exploded view of transmission showing Spring 3.2191 (pn 330087) and Plug 3.2192 (pn 367794)

3.2191	SPRING - COUNTERSHAFT THRUST	
330087	1951-2000-01-03-06-10-11-2100-01-03-06-11-26-30	2
3.2192	PLUG - COUNTERSHAFT THRUST SPRING	
367794	1951-2000-01-03-06-10-11-2100-01-03-06-11-26-30	2
