PACKARD MASTER SERVICEMEN!

COURTESY LIGHTS

19th SERIES

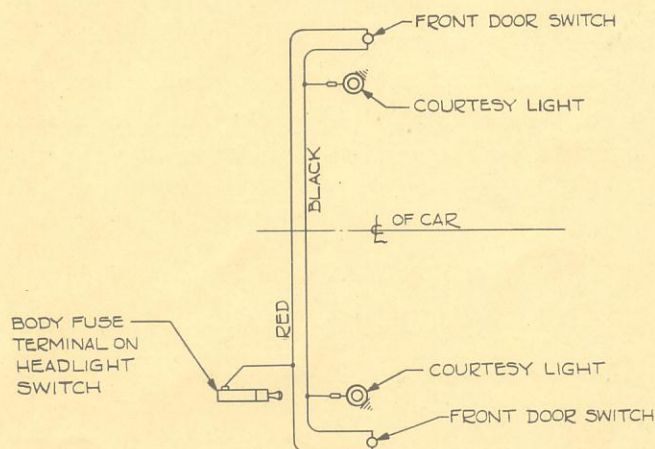
We now have available a service installation of front compartment courtesy lights which can be sold to the owners of the earlier 19th Series cars not fitted with these lights.

1. Drill one 13/64" diameter hole in each corner of the lower flange of instrument board approximately 7/32" from the front edge and between the two rivet heads at that point.

2. On the face of each front door hinge pillar measure down 5" from lower edge of top hinge and drill 13/16" diameter hole in center of pillar.
3. Use courtesy light switch flange as a template, and center punch for the two No. 40 (.098")

diameter above and below the large center hole.
