VOL. 9 No. 8

APRIL 15, 1935

## INTELLIGENT SERVICE

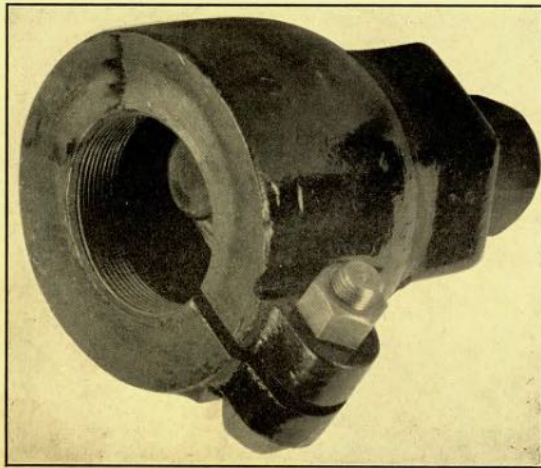
## REAR WHEEL PULLER SHELL AND REAR WHEEL PULLER SHELL SCREW

Shell—Part No. 176958      Screw—Part No. 61577

These two parts will make a complete wheel puller at a reasonable price. See Parts Price List for prices.

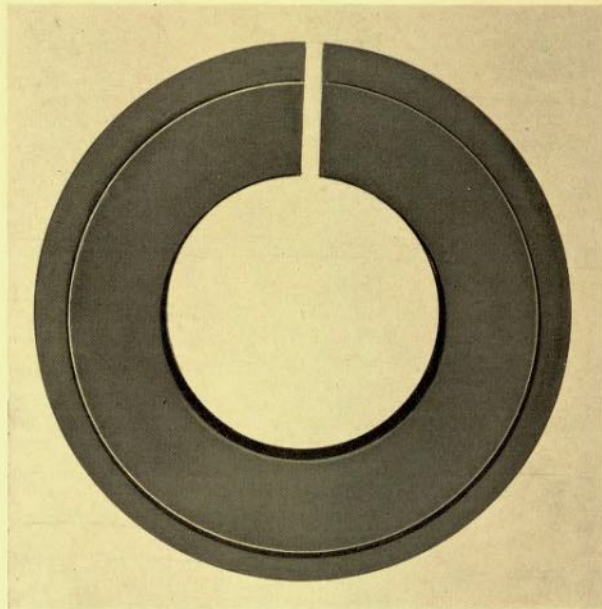
## REAR WHEEL PULLER ADAPTER

Tool No. S. T. 5040 (Used with S. T. 955)

This heavy duty wheel puller adapter is designed to fit the S. T. 955 Wheel Puller.
