PACKARD

Service Counselor

VOL. 19, NO. 5

MAY, 1945

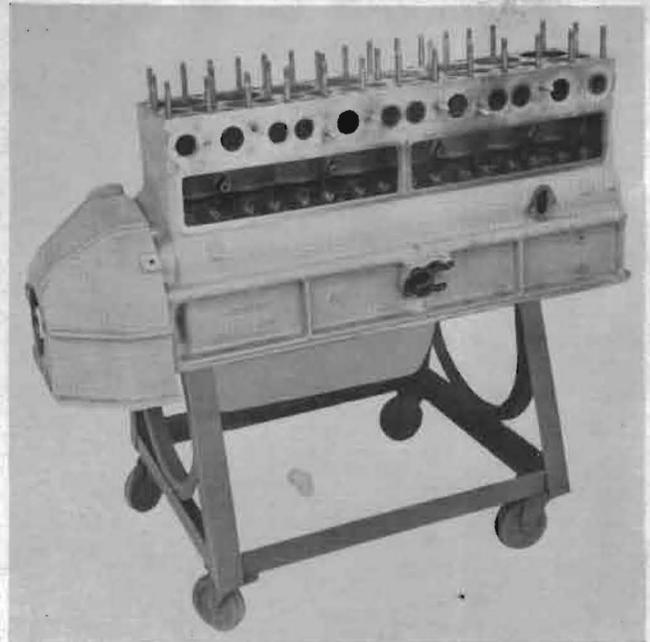
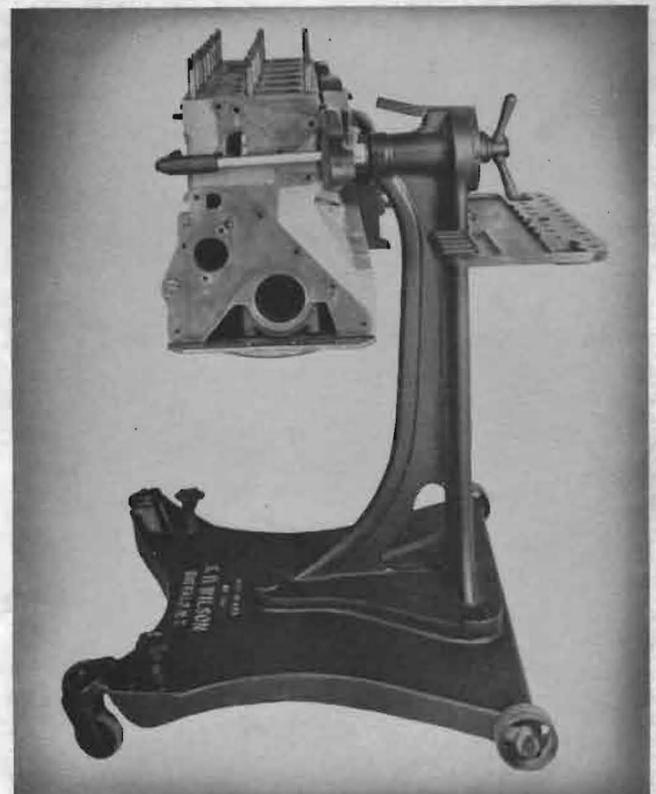
This equipment in every shop will not only expedite the work, but since the stand and

dolly make an important contribution to bettering mechanics' working conditions, efficiency

and quality of work will be improved.

The Engine Stand is \$59.50 and the Dolly \$16.00 each—A priority is required on the Dolly.
