VOL. 14 No. 24

DECEMBER 15, 1940

To all Packard Servicemen everywhere:

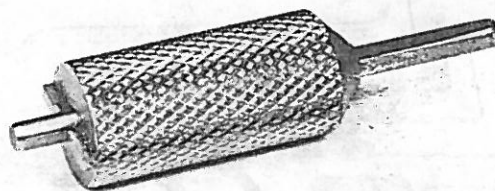
Tool No. ST-10175

ELECTROMATIC CLUTCH SCREW DRIVER AND WRENCH

This tool is used for adjusting first and reverse solenoid for faster or slower clutch engagement.

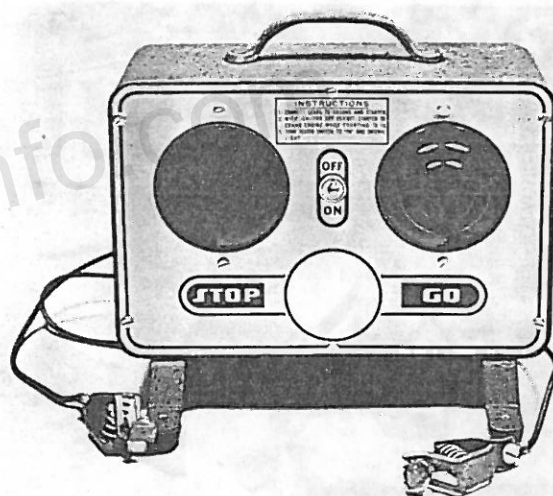
Tool No. ST-5215.

BATTERY TESTER STOP AND GO

STOP AND GO Battery Tester, is a medium for merchandising battery service. You can show a customer in a few seconds whether or not his battery is in satisfactory condition without taking it out of the car.

1. Attach one clip to the starter terminal and the other clip to the ground.

3. With ignition off, permit starter to crank the engine for 10 or 15 seconds. Then hold the toggle switch on the battery tester.

3. If the green lamp lights, the battery and circuit are in satisfactory condition. If the red lamp lights, it indicates excessive voltage drop in the battery or starter circuit.

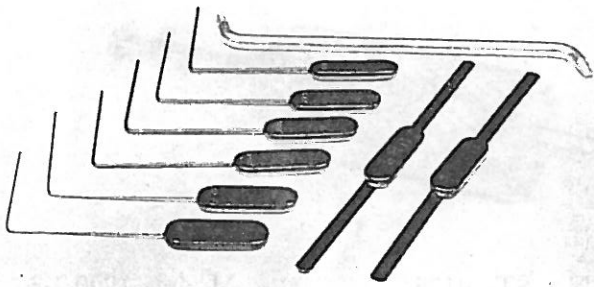
Tool No. ST-5214. Suggested List Price, \$1.95

VOLTAGE REGULATOR ADJUSTING GAUGES AND FEELERS

This regulator service package consists of six wire gauges, two feeler gauges, and one bending tool. It is essential for adjusting all types of automotive regulators.

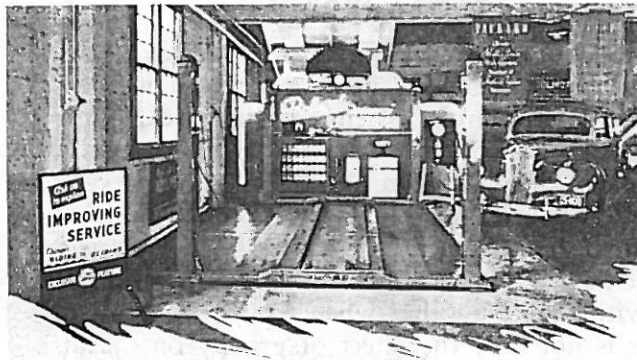
MODERN LUBRICATION

Merchandising lubrication calls for a well located, neat, clean department. Good equipment and a well painted background invite your customers to use your lubrication facilities.

Neon signs added to the display are low in operating cost and add a great deal to the attention-getting ability of this department.
