What Happens When Owners Patronize Independent Shops?

Packard Motor Car Company Technical Service Department Detroit, Michigan

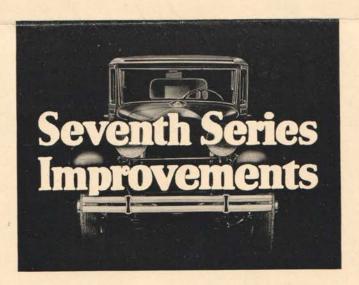
Window Lifter Tubing

A rubber tubing has been used for some time on the bottom of the window glass and lately an improved type has been supplied. A special type of sponge rubber is now used in production and can be obtained for service replacements.

Order Part No. 176787 Sponge Rubber Bumper in 28 inch lengths and make all replacements of the tube type rubber which does not stand up with the bumper of sponge rubber. In making the installation be sure the side with the fabric faces toward the outside of the window.
