Winter, and What to Do About It!

WE are not going into detail on how to prepare a Packard car for winter driving. There are, however, three items that we would like to call to your attention.

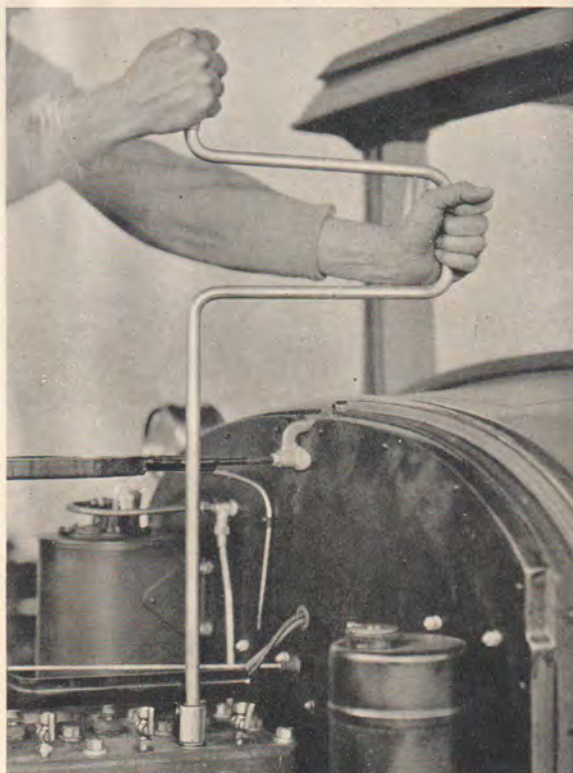
A Bargain

Buy While They Last at Cost Price

\$.95—Includes Handle and Socket

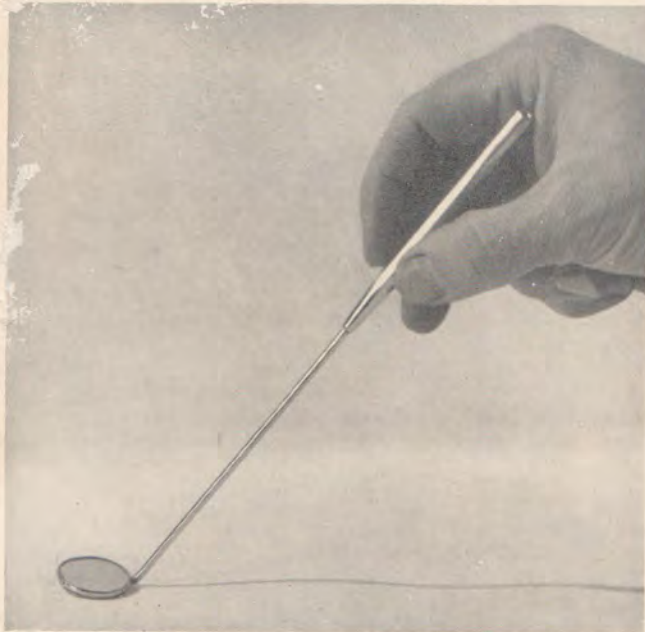
Special Mirror

CAMSHAFT AND OIL PUMP GEAR MIRROR

Tool No. S. T. 896 Model 905-906 Net \$1.00
