PACKARD

Service Counselor

VOL. 21 NO. 3

FEBRUARY 1, 1947

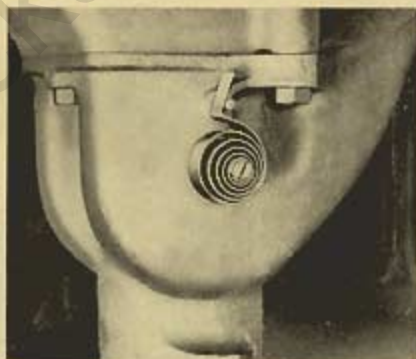
This automatic heat control, consisting of a butterfly valve, shaft, balancing weight and a thermostatic spring, is fitted into the exhaust manifold in such a manner that exhaust gas may be circulated around the center portion of the intake manifold.

In the "cold" position of the valve, all of the exhaust gas circulates through the jacket in the center of the intake manifold. In the extreme "hot" position, all of the exhaust gas is directed into the exhaust pipe.

When the engine is started and the exhaust manifold is cold, the thermostatic spring holds the valve in the cold position and permits the hot exhaust gas to circulate around the fuel mixture inlet passages in the center of the intake manifold. This circulation of hot gas causes the intake manifold to heat up rapidly resulting in

As the engine warms up, the thermostatic spring expands reducing the tension which holds the valve in the cold position. The balancing weight then begins to turn the valve toward the hot position permitting part of the exhaust gas to be directed into the exhaust pipe, by-passing the jacket around the inlet passages.

When the engine temperature is up to normal the greater portion of the exhaust gas is by-passed directly into the exhaust pipe. The movement of the valve toward the hot position is accomplished by the balance weight and the pressure of the exhaust gas. As the engine speed is increased, the valve will move toward the hot position as the pressure of the exhaust gas increases. As the engine speed is reduced, the exhaust gas pressure decreases allowing

Adjustment of the heat control valve should be made when the temperature of the manifold is between 60 and 70 degrees or at room temperature. The thermostat should hold the valve firmly in the cold position. If the valve does not seat firmly, shorten the thermostat by bending the free end to increase the tension and recheck.

On the Six and Eight models, the free end of the thermostat hooks over an anchor pin; on Super Eight models, the free end is anchored in a slot in the thermostat cover. The adjustment and method of adjusting is the same for both.
