# Packard SERVICE TECHNICAL Bulletin

52T-37

December 31, 1952

SUBJECT: CAMPAIGN - 4-BARREL "WCFB" CARBURETOR THROTTLE OPERATING ROD  
CARBURETOR THROTTLE FLEX SPRING  
MODELS-2631-2602-2606 and 2626

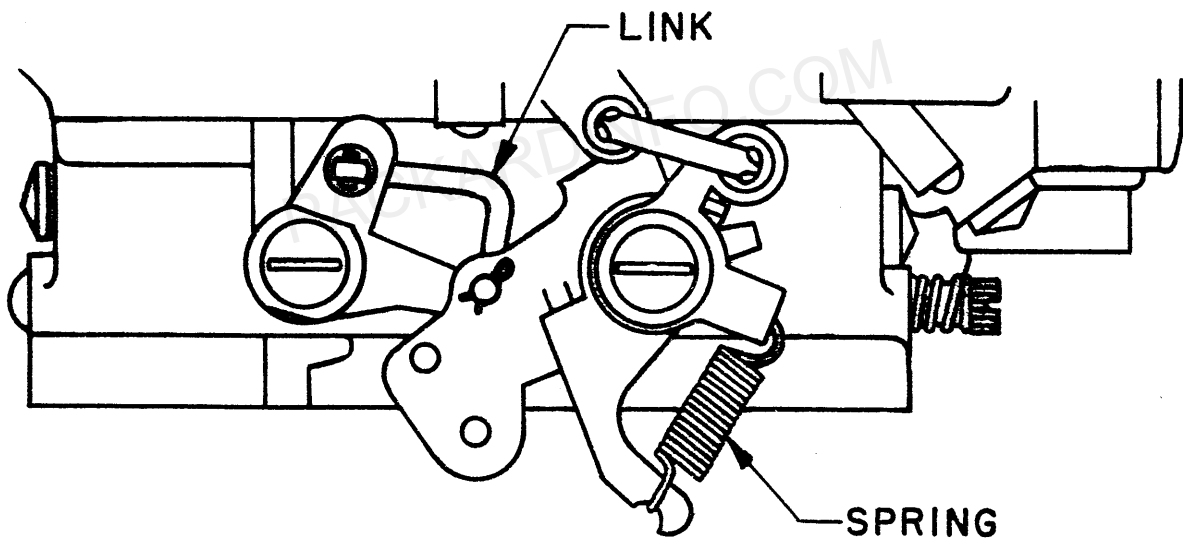
When the operating rod is installed in this manner, it will not permit the secondary throttle valves to open at the pre-determined time. The operating rod must be installed from the inside of the levers with the retaining clips on the outside, "See Illustration on reverse side".

It has been found that the choke valve does not open when the accelerator is pressed hard to the floor in the event an engine becomes flooded. The spring on the throttle lever, "See Illustration", should stretch out and the choke valve open  $9/32$ " before the throttle connecting rod over-ride moves.

The new spring which is copper colored and has less tension is available at the parts warehouse. It may be ordered under Part Number 436715, Motor Carburetor Throttle Flex Spring (Carter #61-453).

All cars having the 4-barrel carburetors shipped from the factory prior to Engine No. L400758, L600246 must be campaigned. Inspect the operating rod and reverse its installation if necessary. Install the new throttle lever flex spring.
